# Annual MOM Progress Report

2005

Submitted to EPA on February 27, 2006

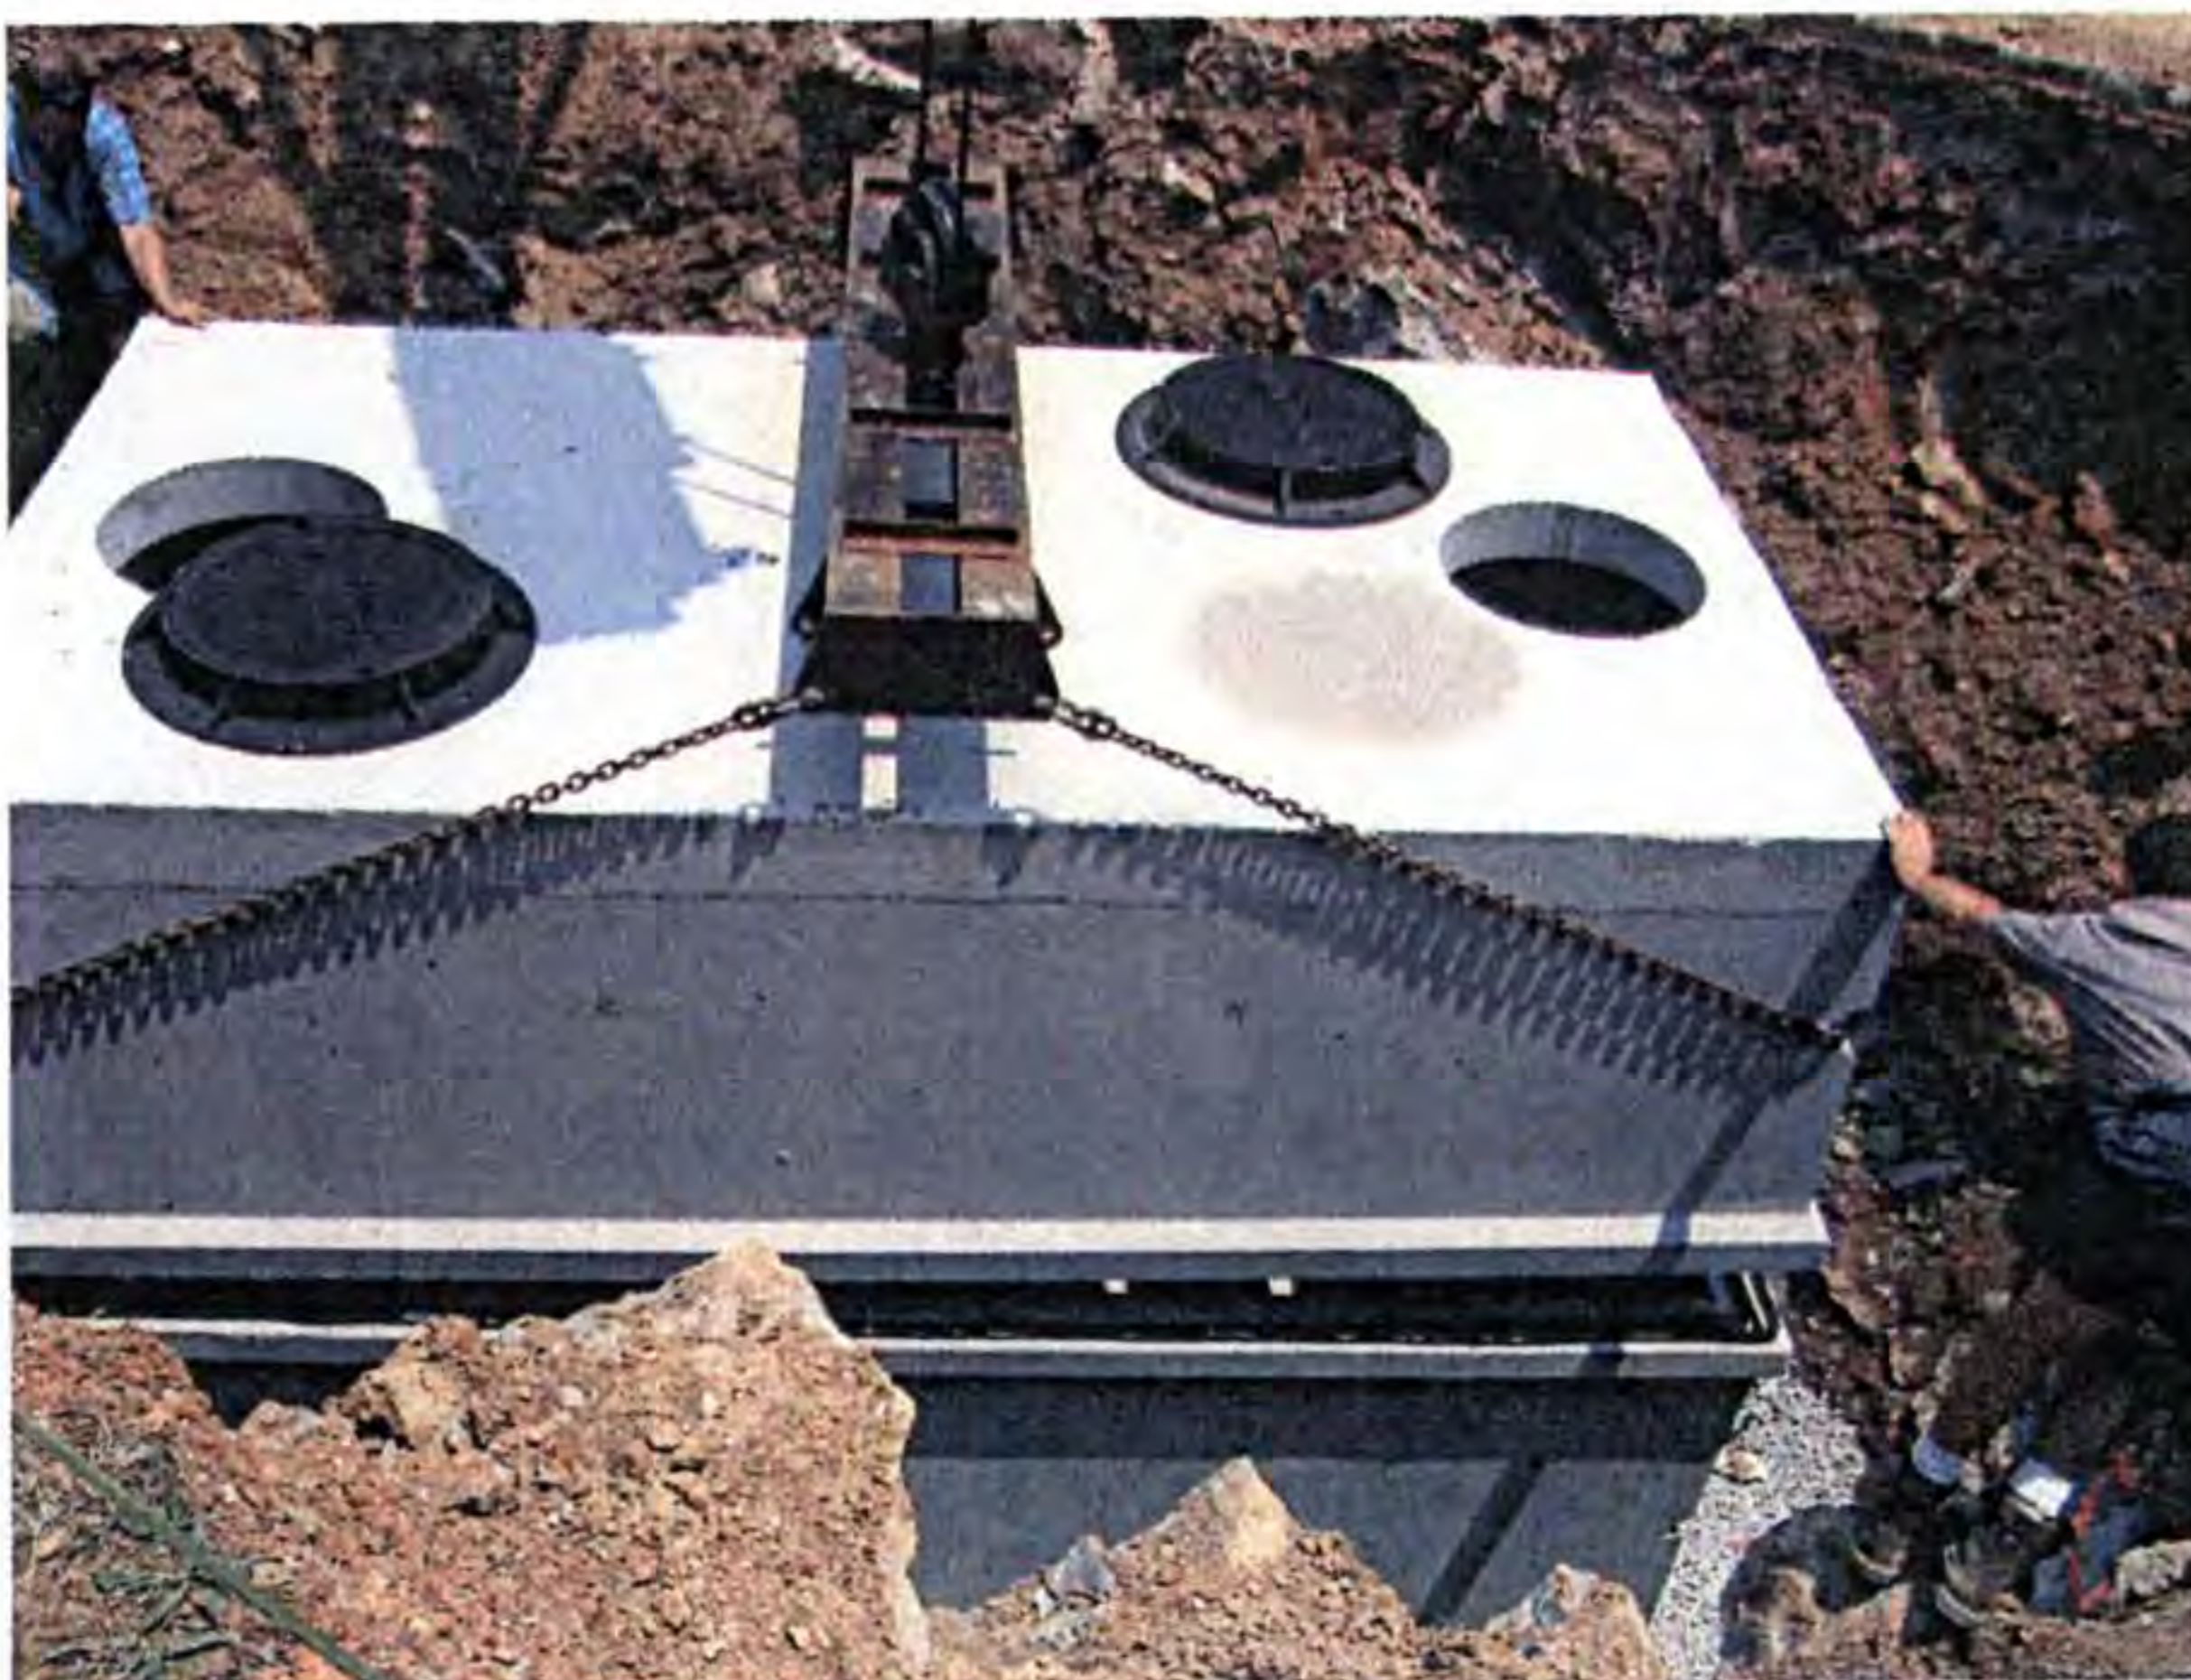
KUB identified two Knox County Schools food-preparation sites as major contributors to growing grease problems in their areas: West and Central high schools. KUB required each school to install at least a 2000-gallon grease interceptor (*see photo below*) to help prevent chronic overflows. KUB also put the affected lines on its BA Program for frequent cleaning to control grease until the schools completed the installations.

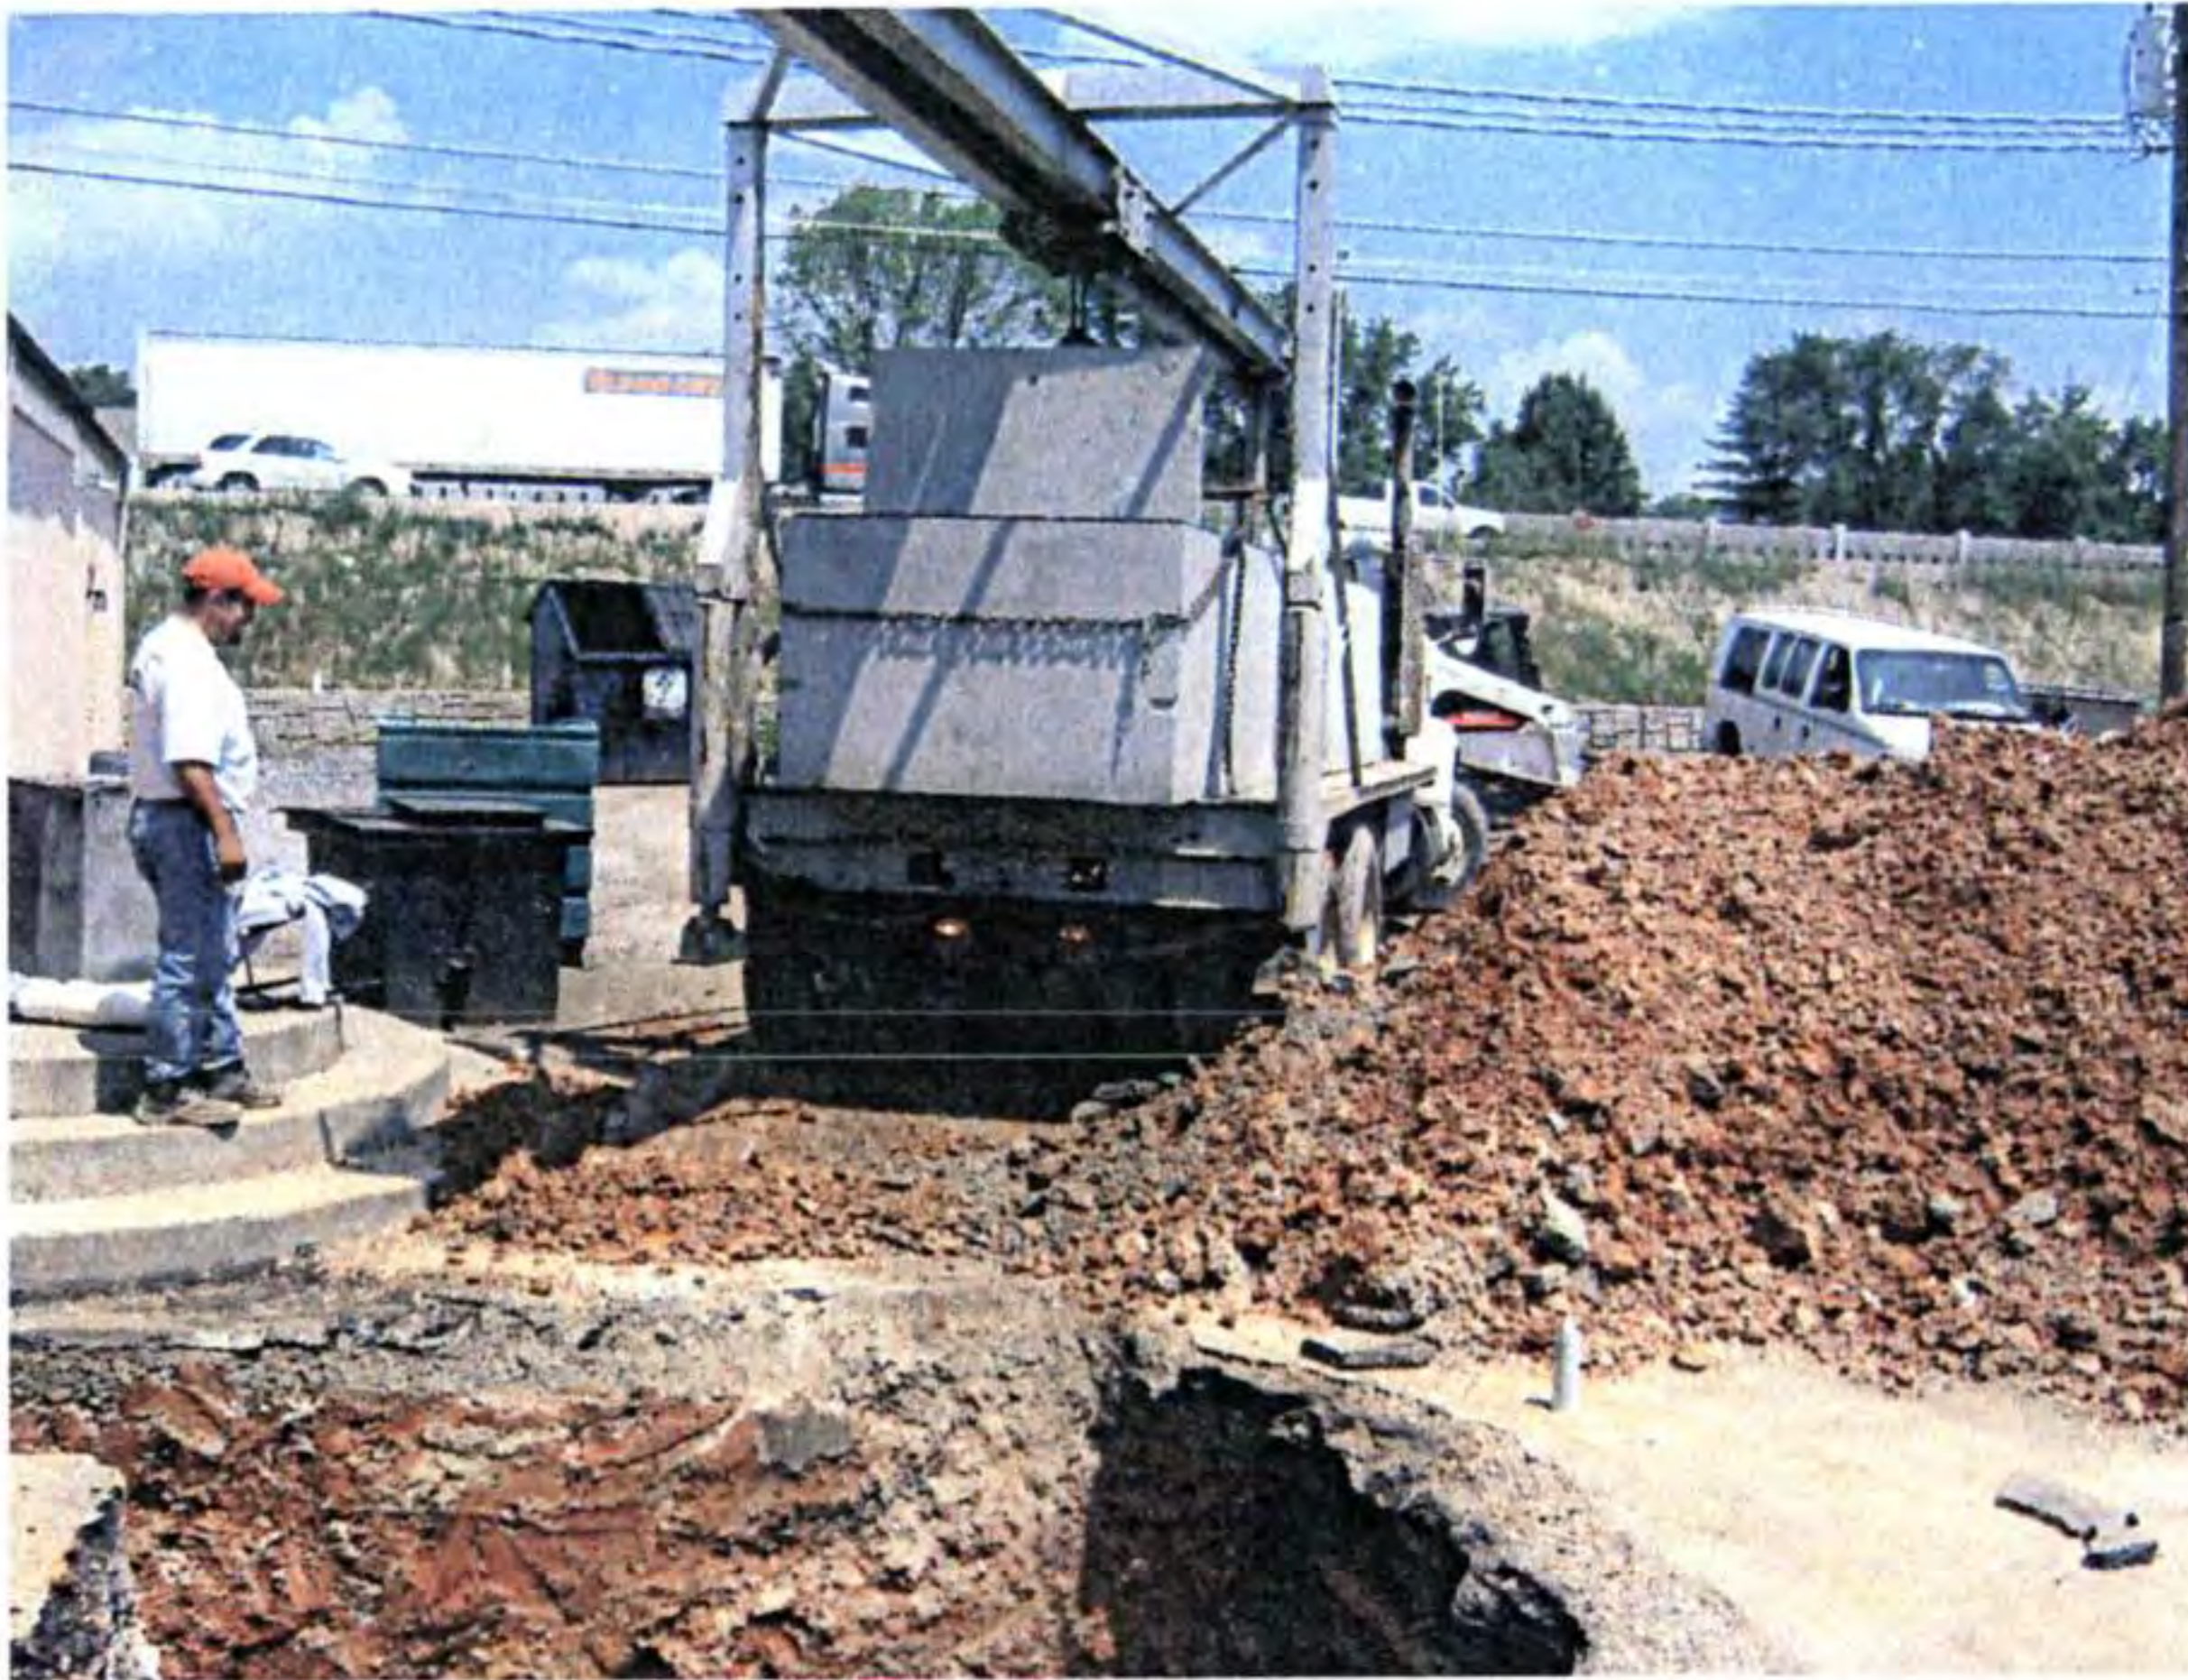
KUB also required Michael's Restaurant, which was contributing to a chronic overflow, to install a 1500-gallon interceptor (*see photo below*). Since that installation (and completed construction projects in the Papermill area), there have been no problems at the former chronic site.

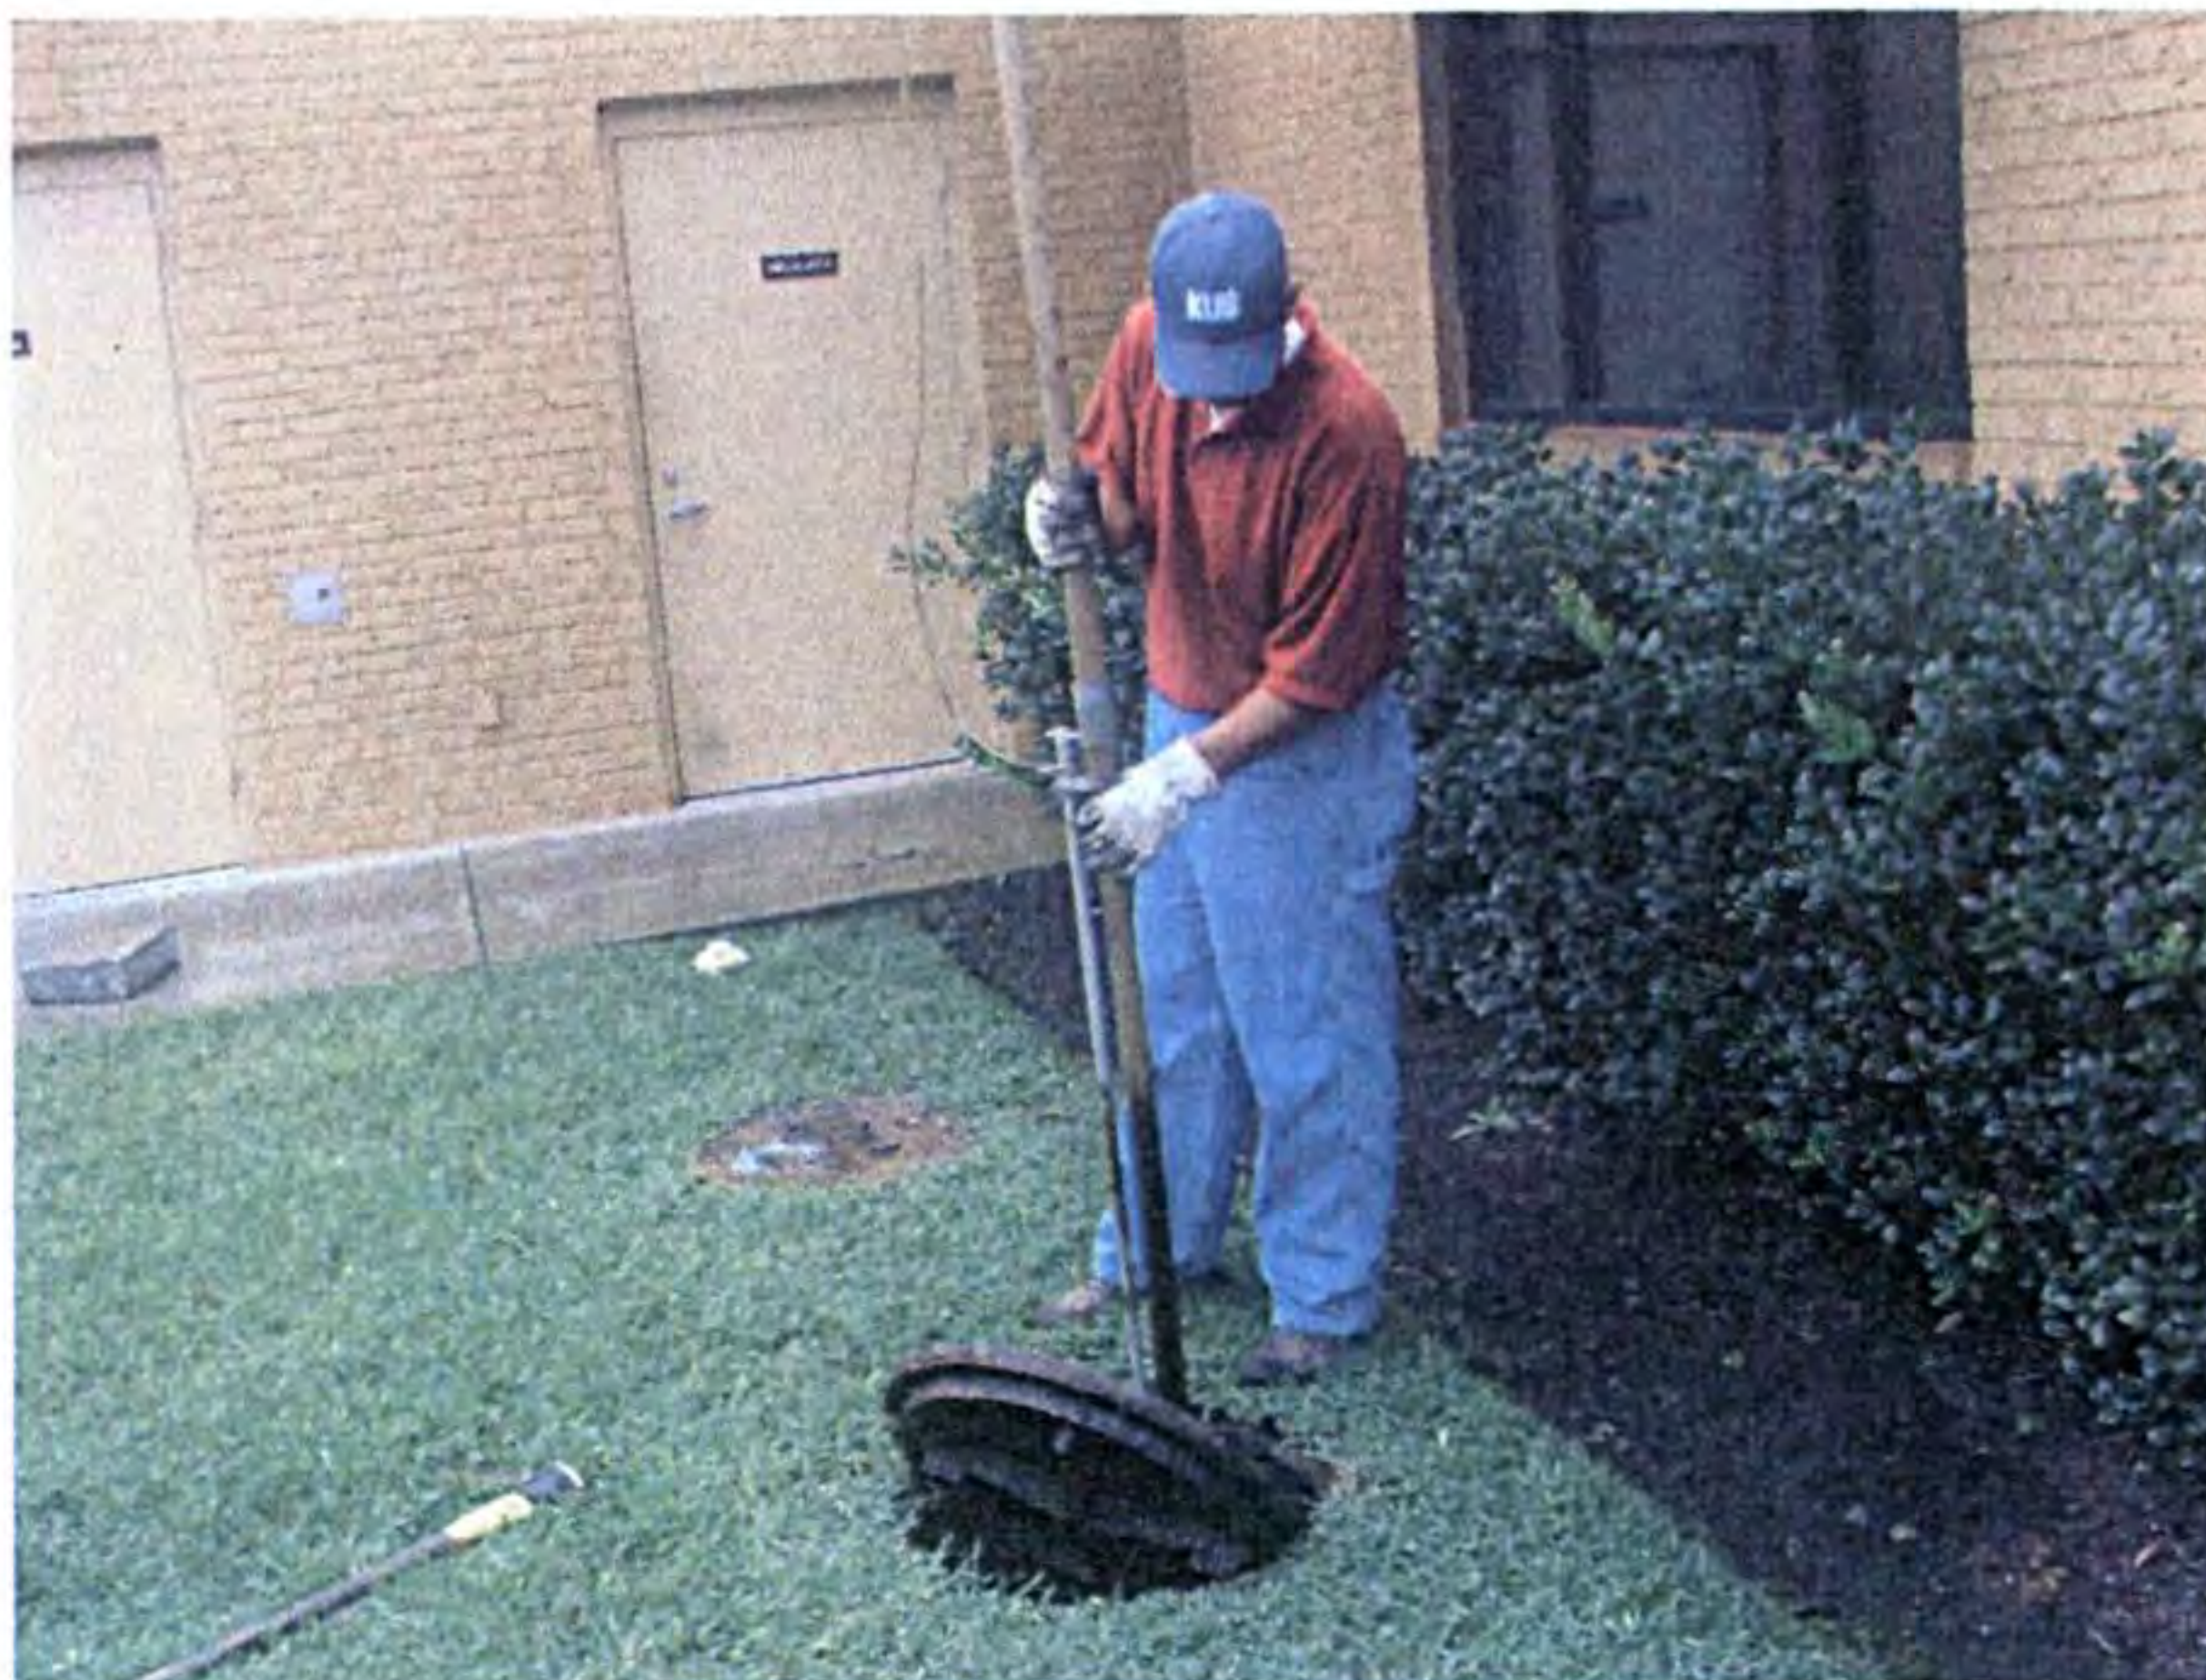
KUB's Grease Control personnel also use a "sludge judge" (*see below*) to measure the effectiveness of grease interceptors at FSFs. The tool takes a core sample from the interceptor and measures the percent of solids. If the solids are more than 25 percent, the FSF is required to increase the frequency of its pumping schedule.

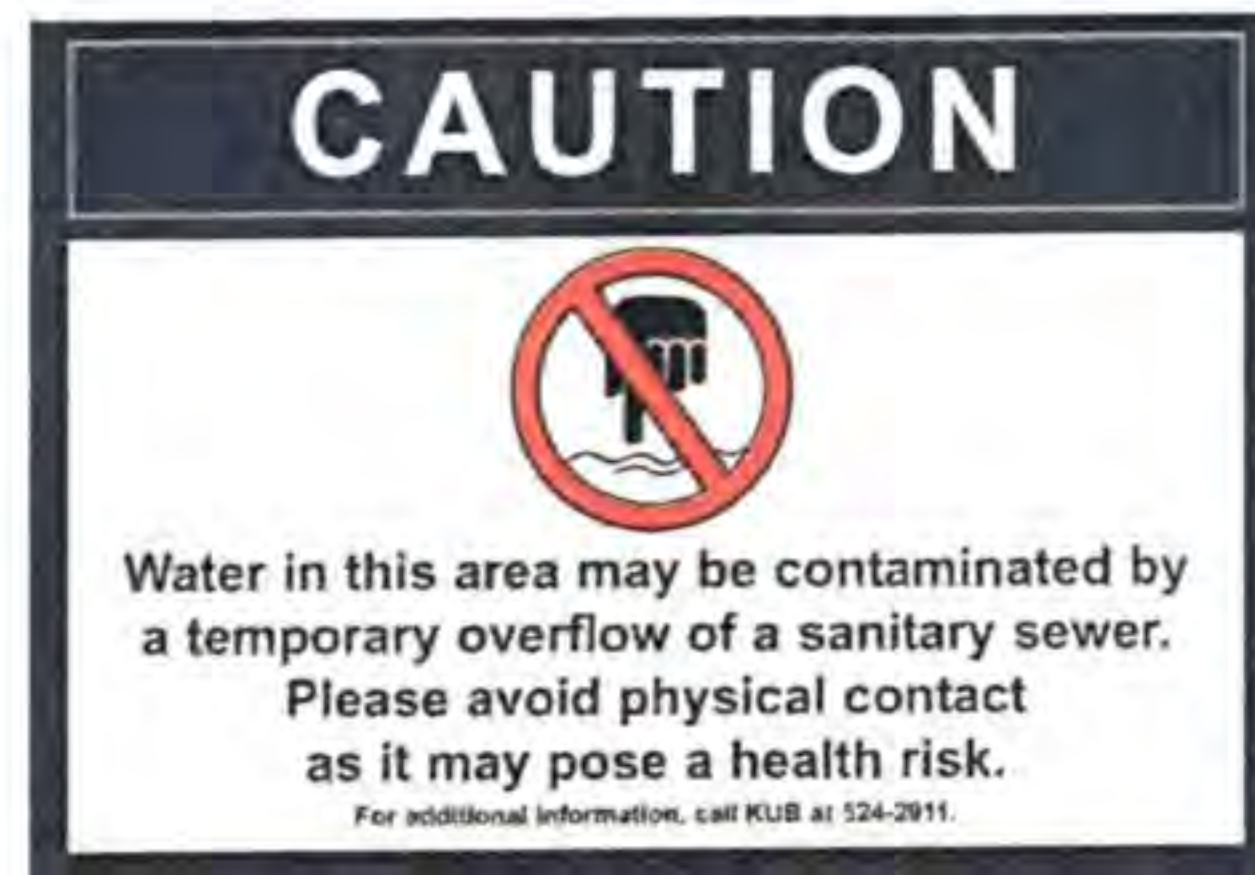
The first overflow that met the agreed criteria occurred December 16, 2005, at 1204 Woodcrest Drive, on an un-named tributary of First Creek. KUB posted overflow signs every 200 yards [for up to 1,000 yards] or at points of public access to help ensure appropriate public notice. The signs were posted for 48 hours after clean up was completed. KUB uses its standard sign for SSO postings in these instances.

KUB continues to post warning signs, along with yellow warning tape to establish a control zone, at all overflow locations. The KUB Web site also includes a log of SSOs events and safety tips on dealing with overflows.
