# Annual MOM Progress Report

2006

Submitted to EPA on February 27, 2007

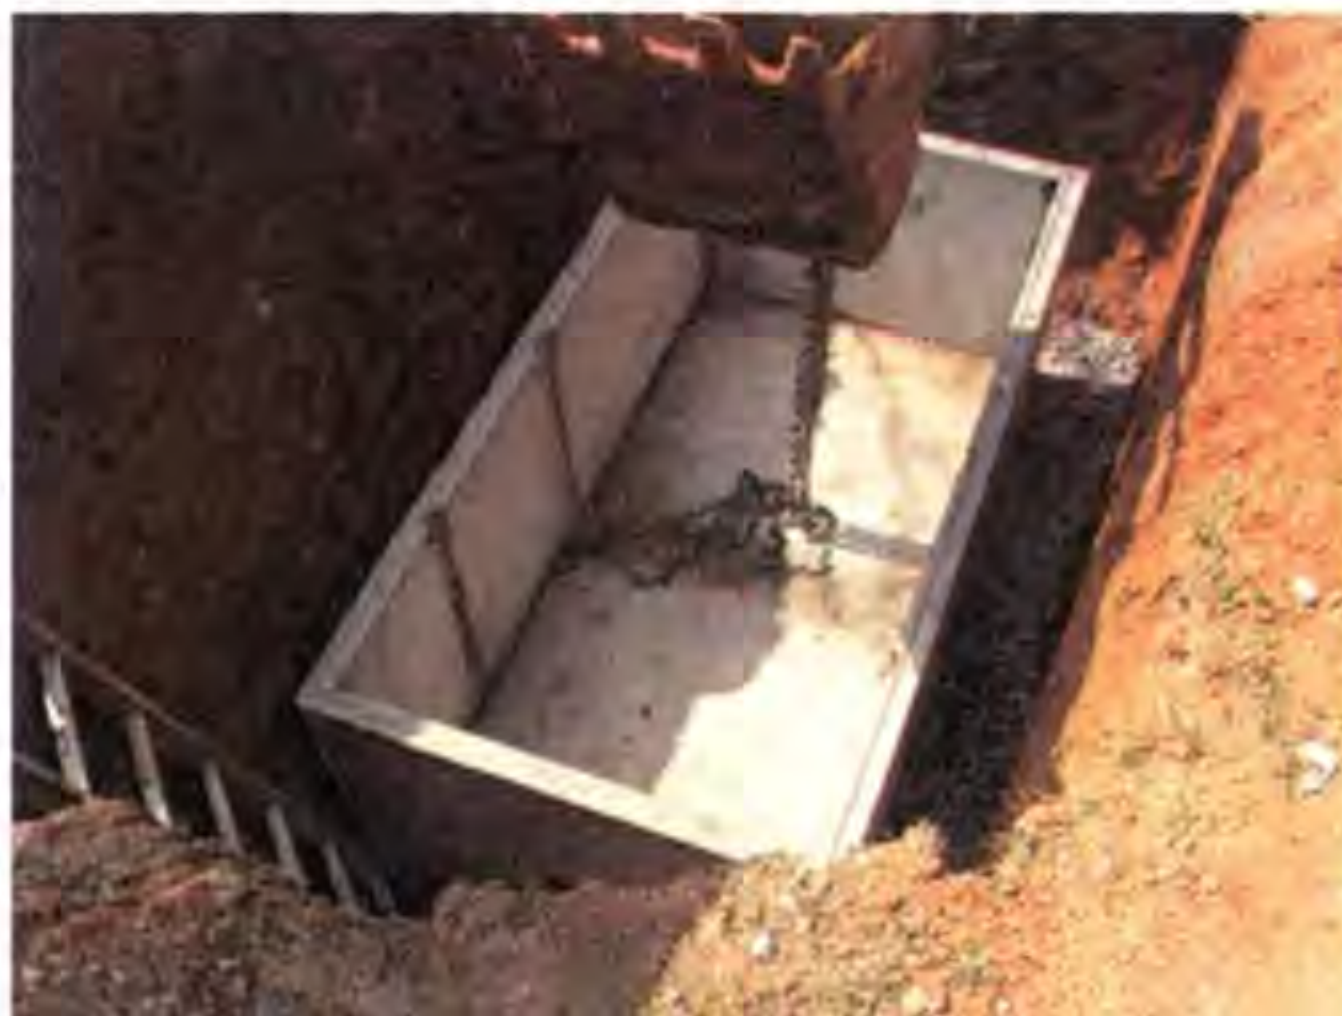
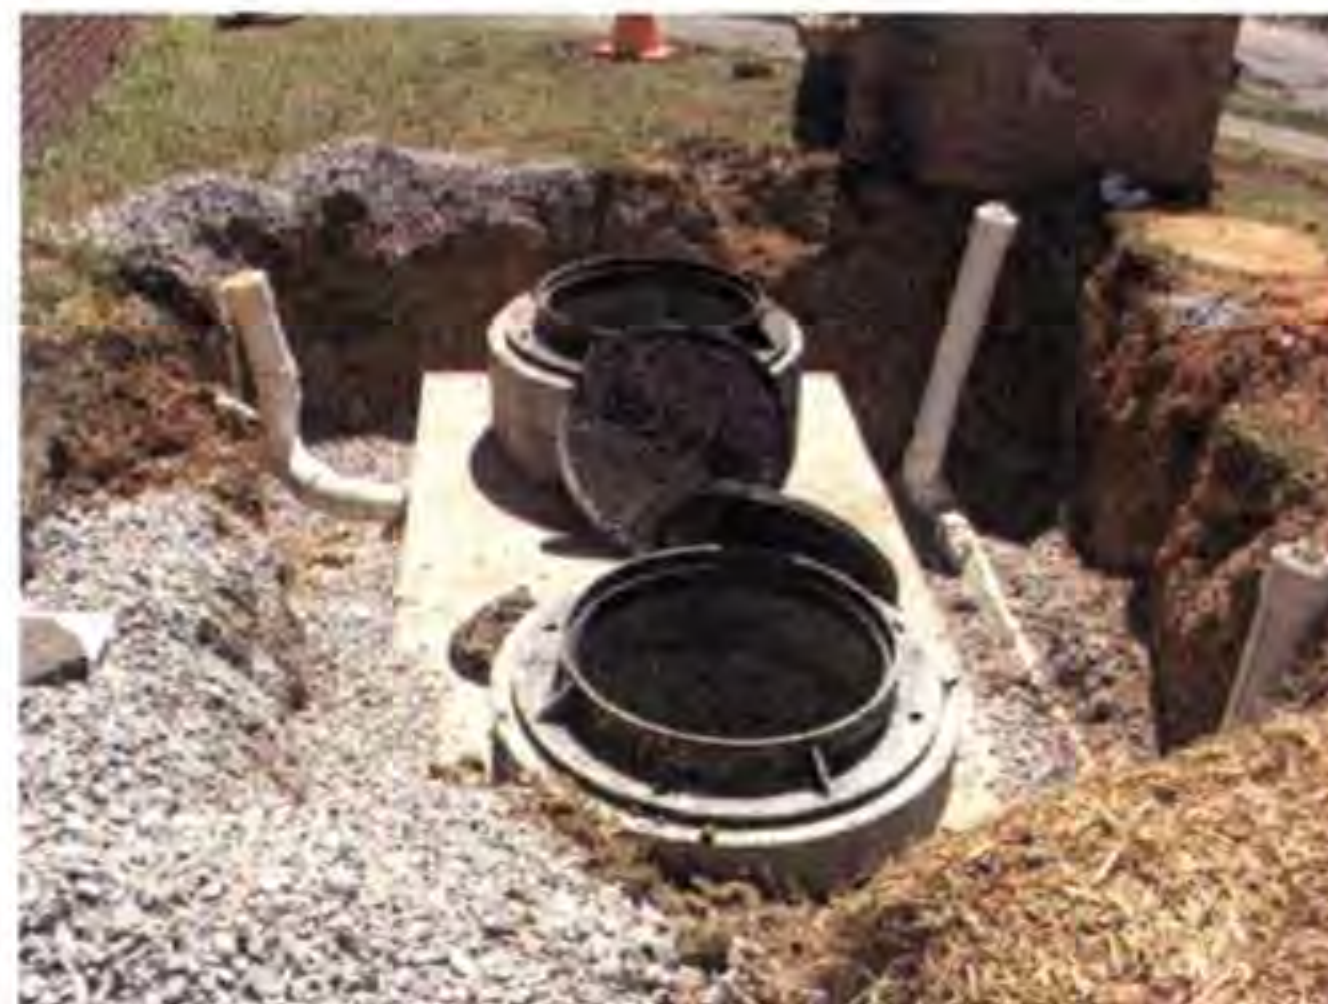
KUB identified seven Knox County Schools food-preparation sites as major contributors to growing grease problems in their areas: East Knox County, Belle Morris, Norwood, Pleasant Ridge, and Spring Hill Elementary; Green Magnet Math and Science Academy; and Gresham Middle. KUB required them to install 1500-gallon grease interceptors (*see photos below*) to help prevent new chronic overflows.

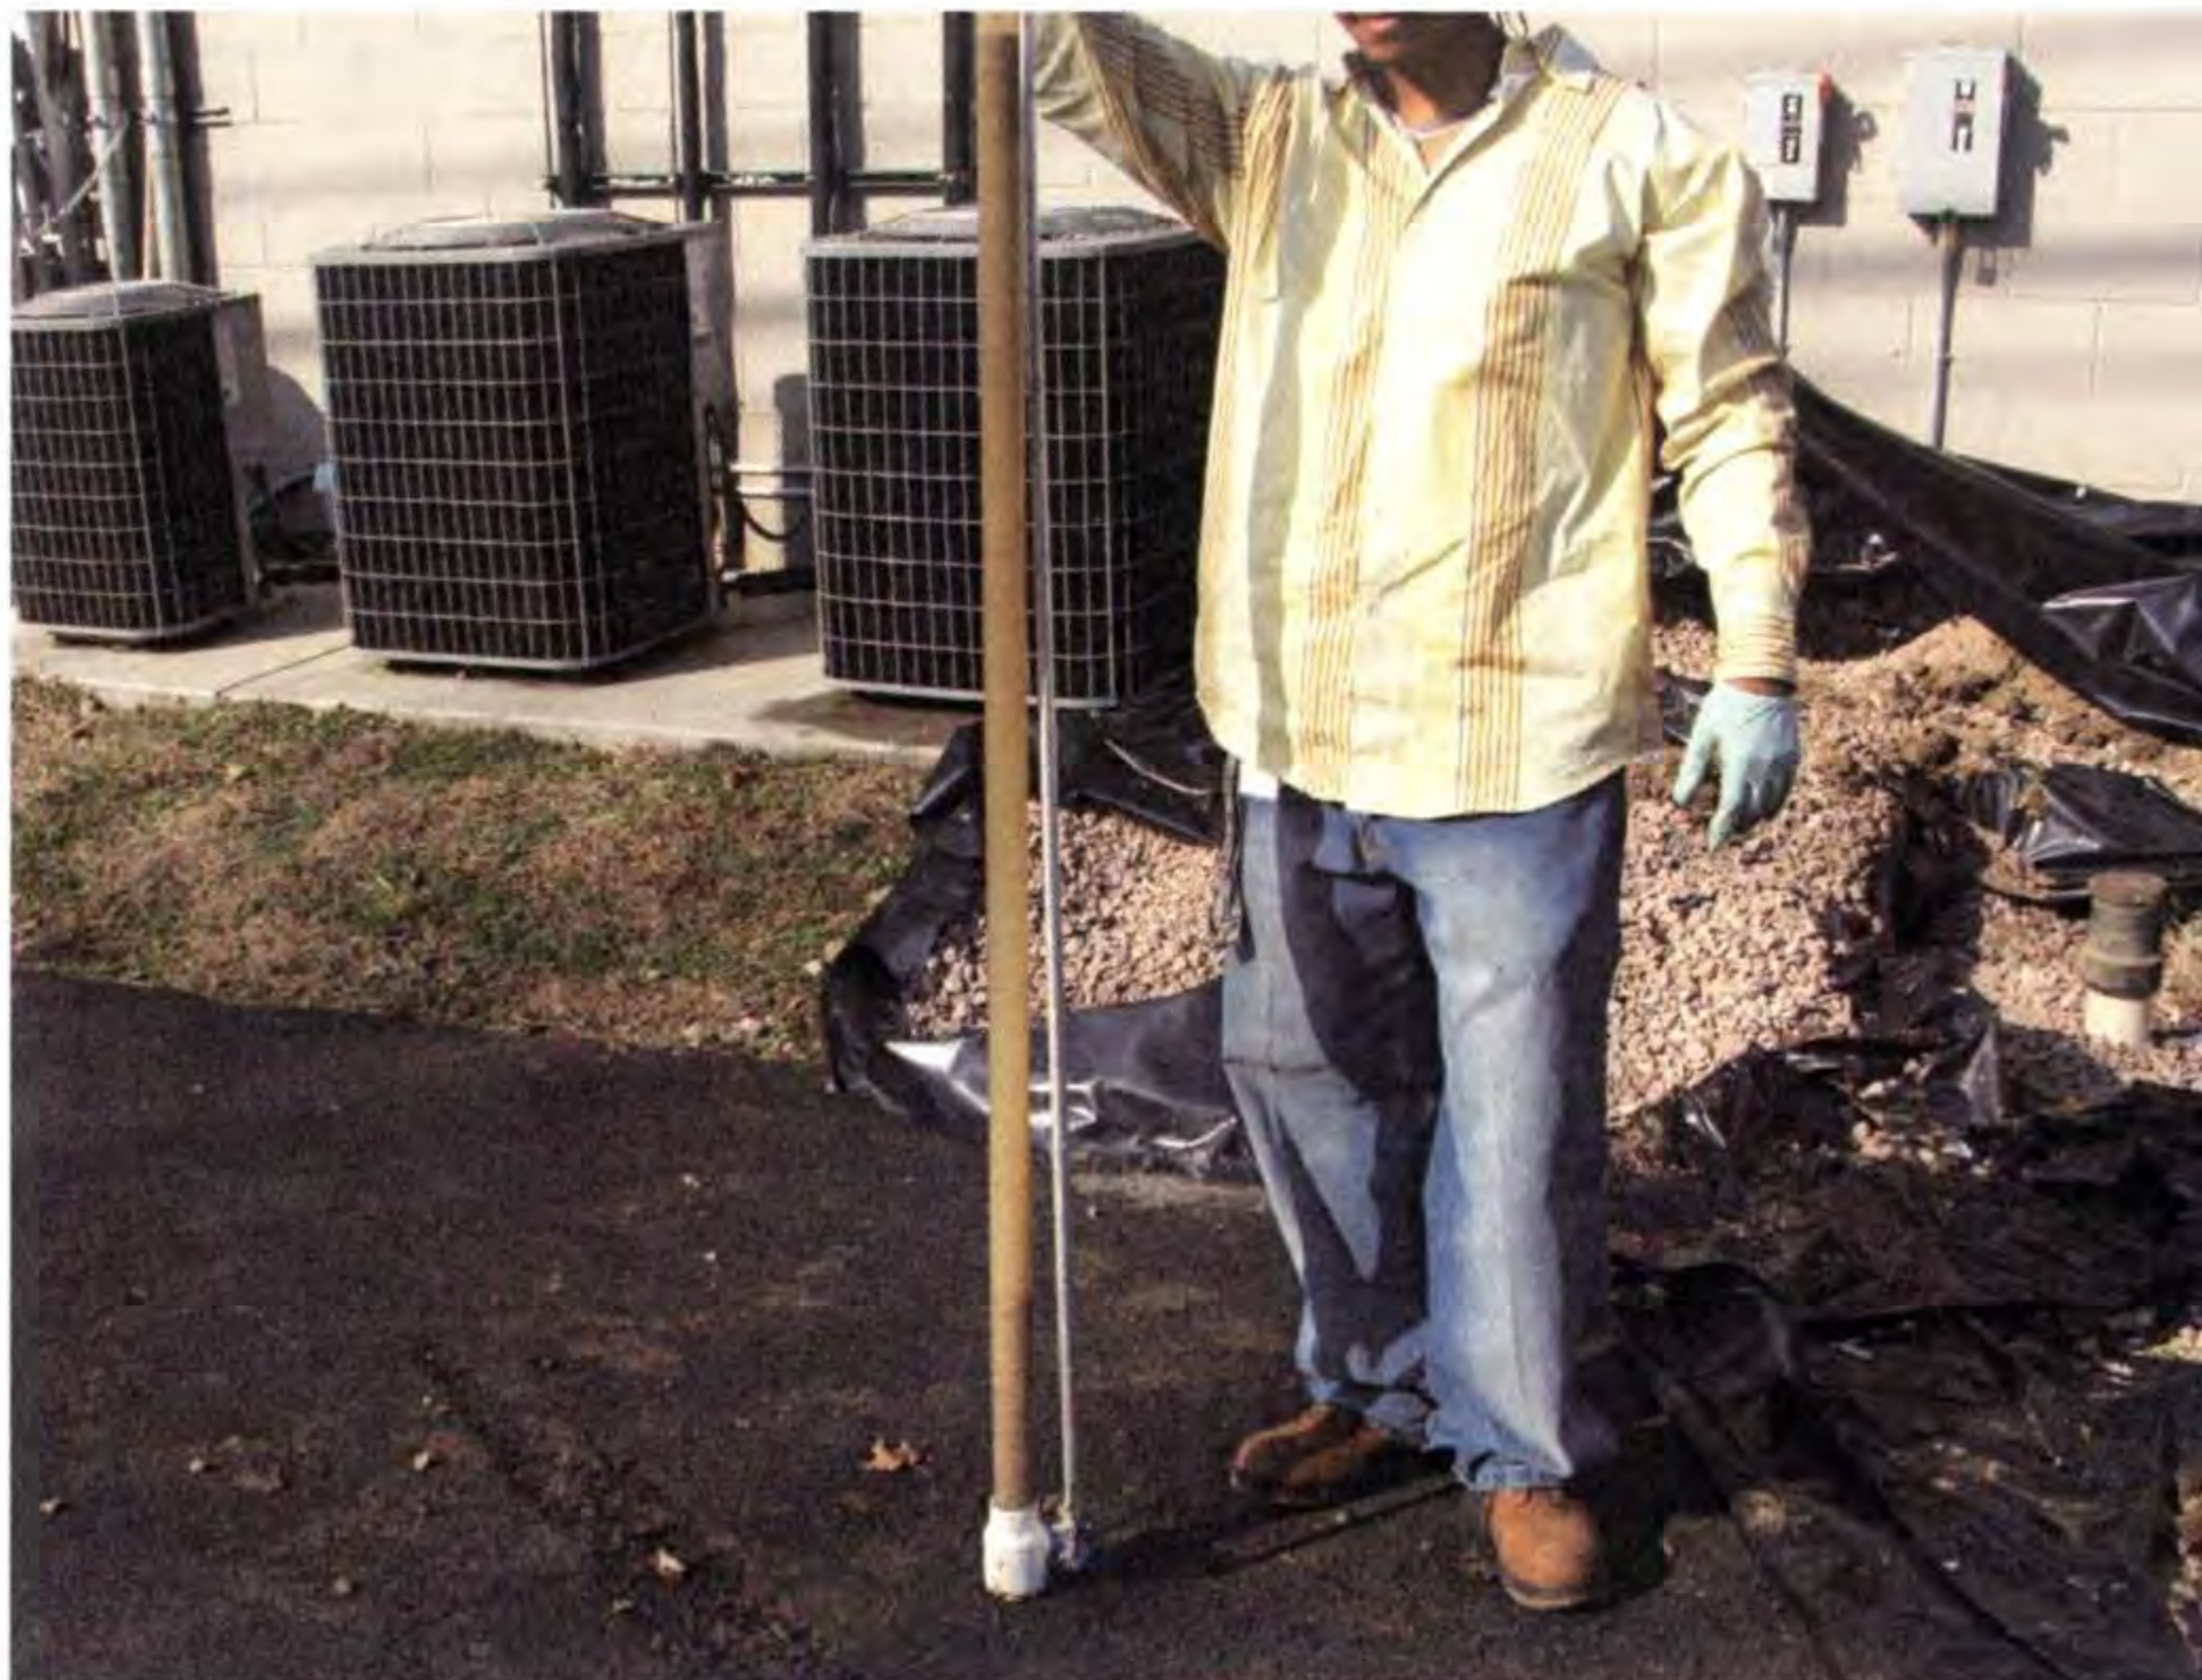
KUB's Grease Control personnel also use a "sludge judge" (*see below*) to measure the effectiveness of grease interceptors at FSFs. The tool takes a core sample from the interceptor and measures the percent of solids. If the solids are more than 25 percent, the FSF is required to increase the frequency of its pumping schedule.

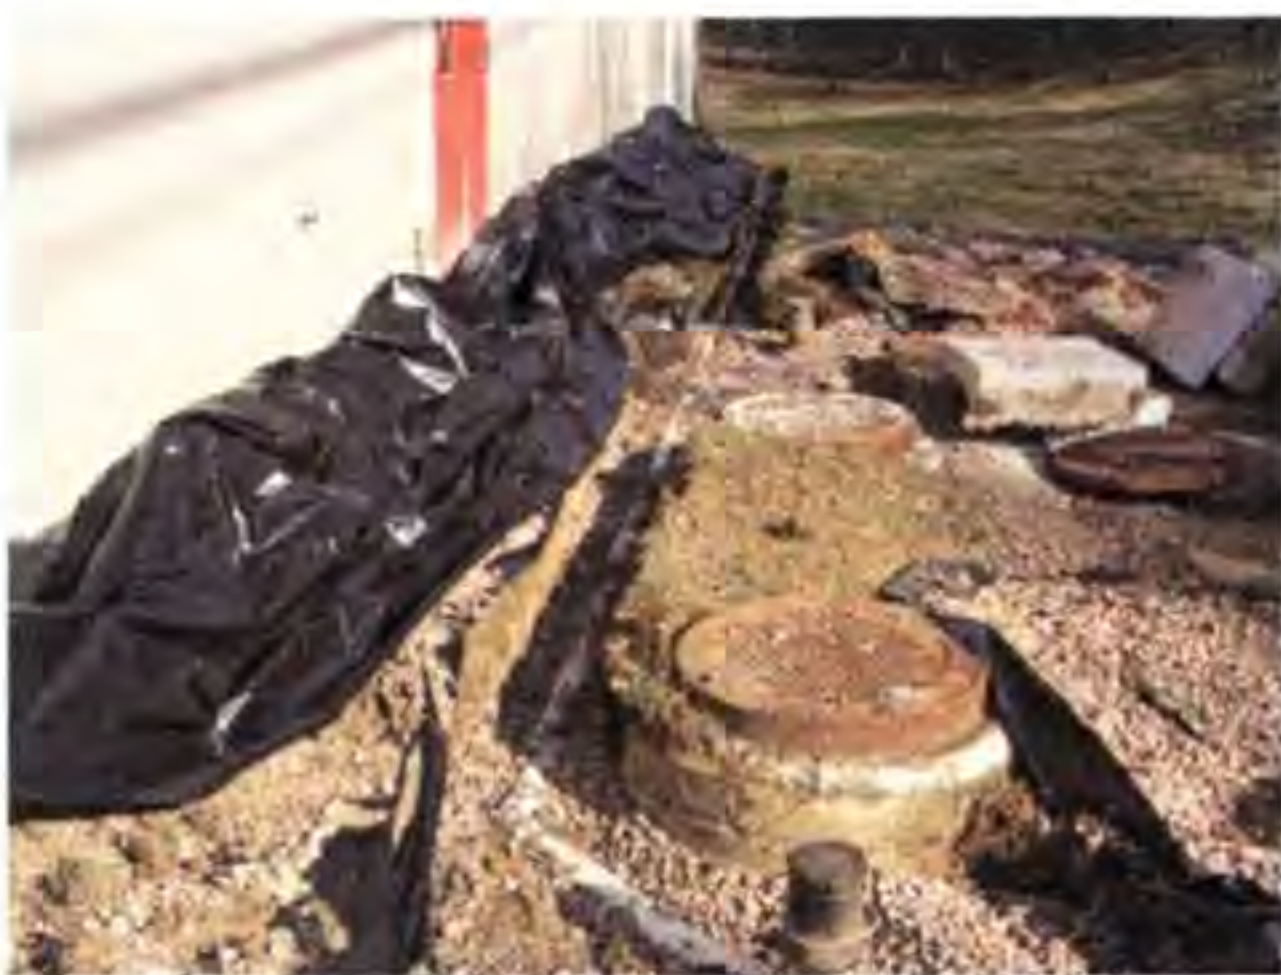
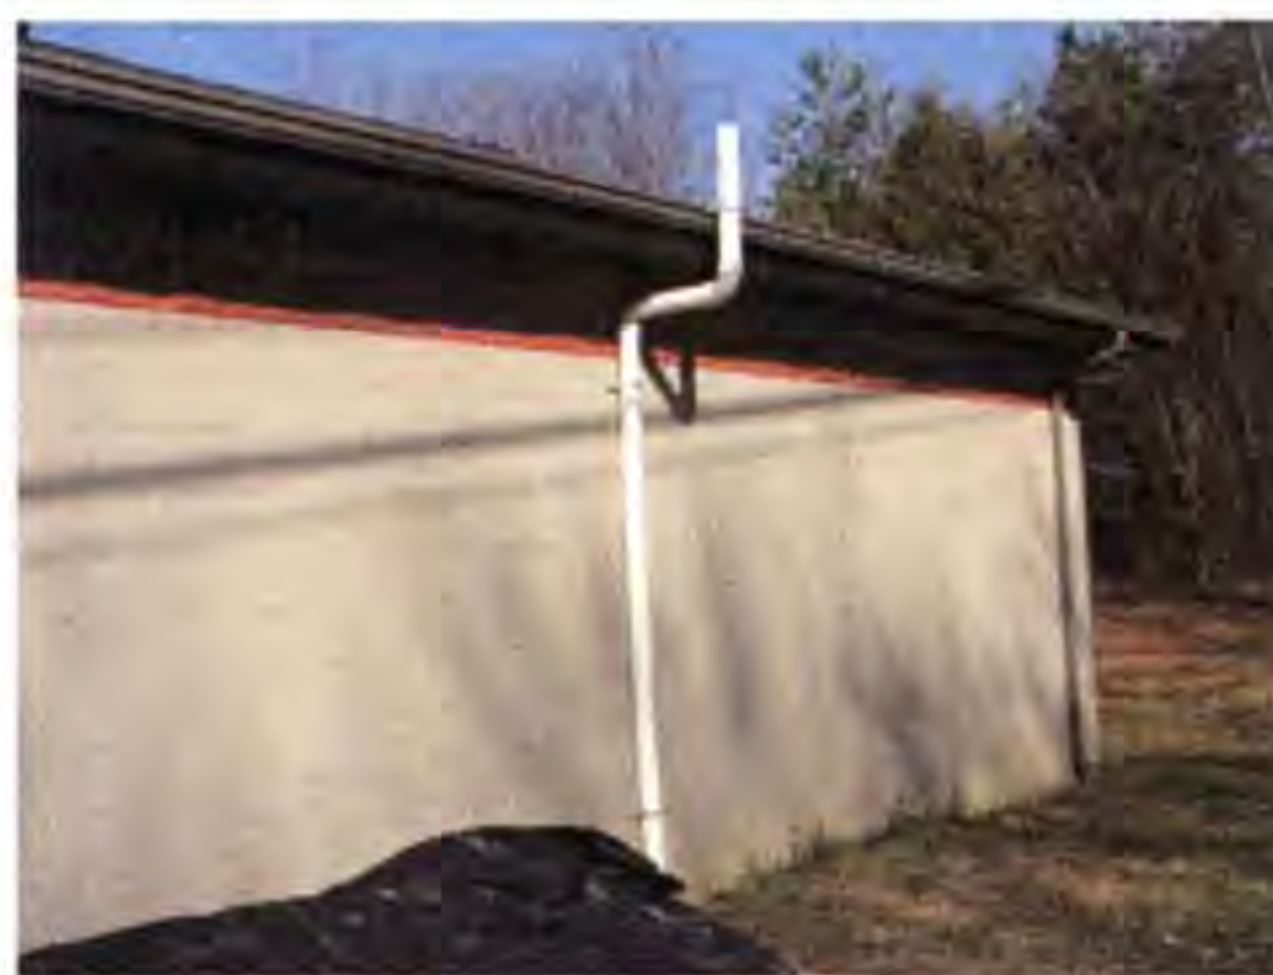
After trying vented grease trap lids, the odor decreased somewhat, but not to the customer's satisfaction. KUB suggested, based on more OdaLog data, venting the interceptor, which turned out to be a successful resolution. [See photos below.]

Inspection and enforcement are not the only aspects of the Grease Control Program. Staff members also work with customers to help solve odor issues and other problems. A good example in 2006 was Kitt's Café. The restaurant was experiencing odor issues from its grease trap, and KUB Grease Control Program staff worked with them to conduct OdaLog studies to measure the odor and test possible solutions.

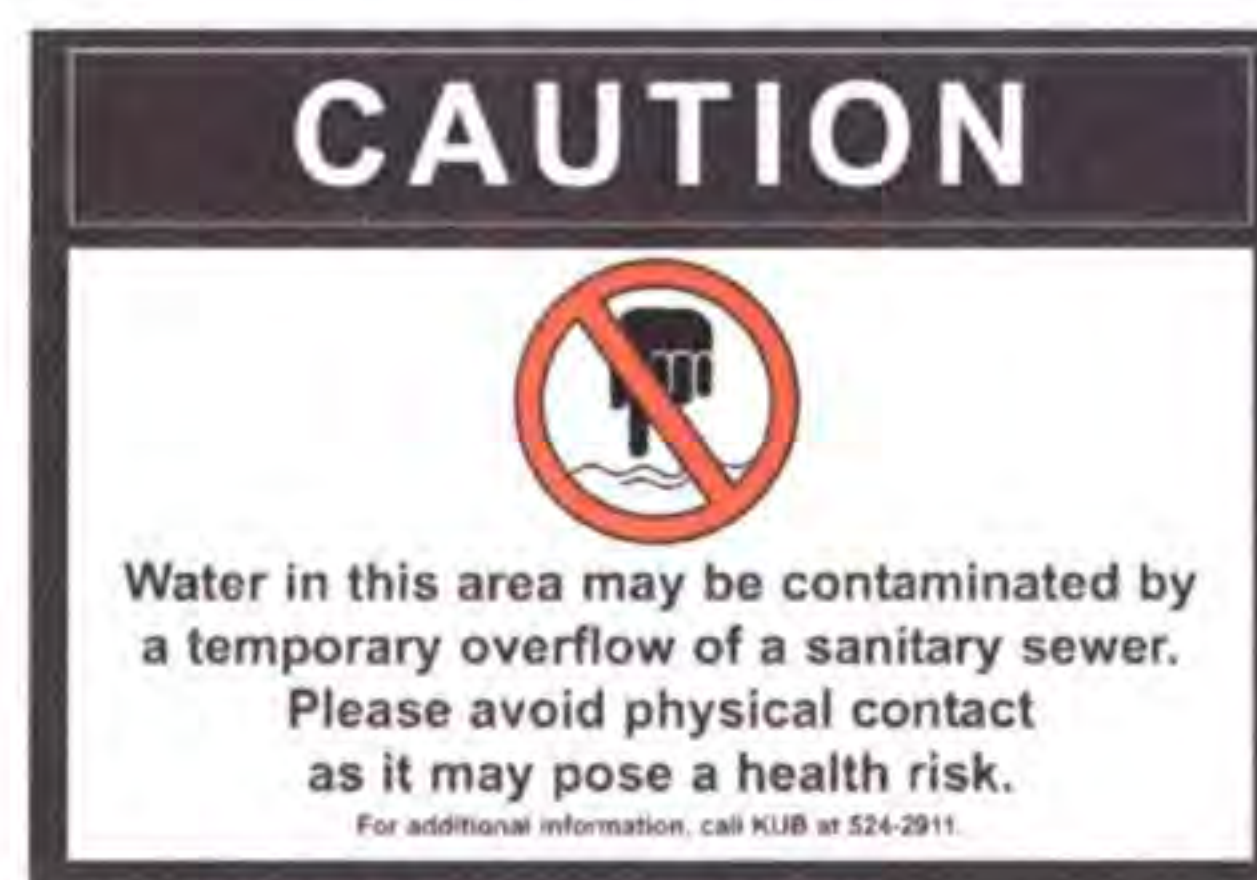
The first overflow that met the agreed criteria occurred December 16, 2005, at 1204 Woodcrest Drive, on an un-named tributary of First Creek. KUB posted overflow signs every 200 yards [for up to 1,000 yards] or at points of public access to help ensure appropriate public notice. The signs are posted by KUB Water Quality personnel and removed after the fecal coliform count returns to background conditions. KUB uses its standard sign for SSO postings in these instances.

KUB continues to post warning signs, along with yellow warning tape to establish a control zone, at overflow locations. The KUB Web site also includes a log of SSOs events and safety tips on dealing with overflows.

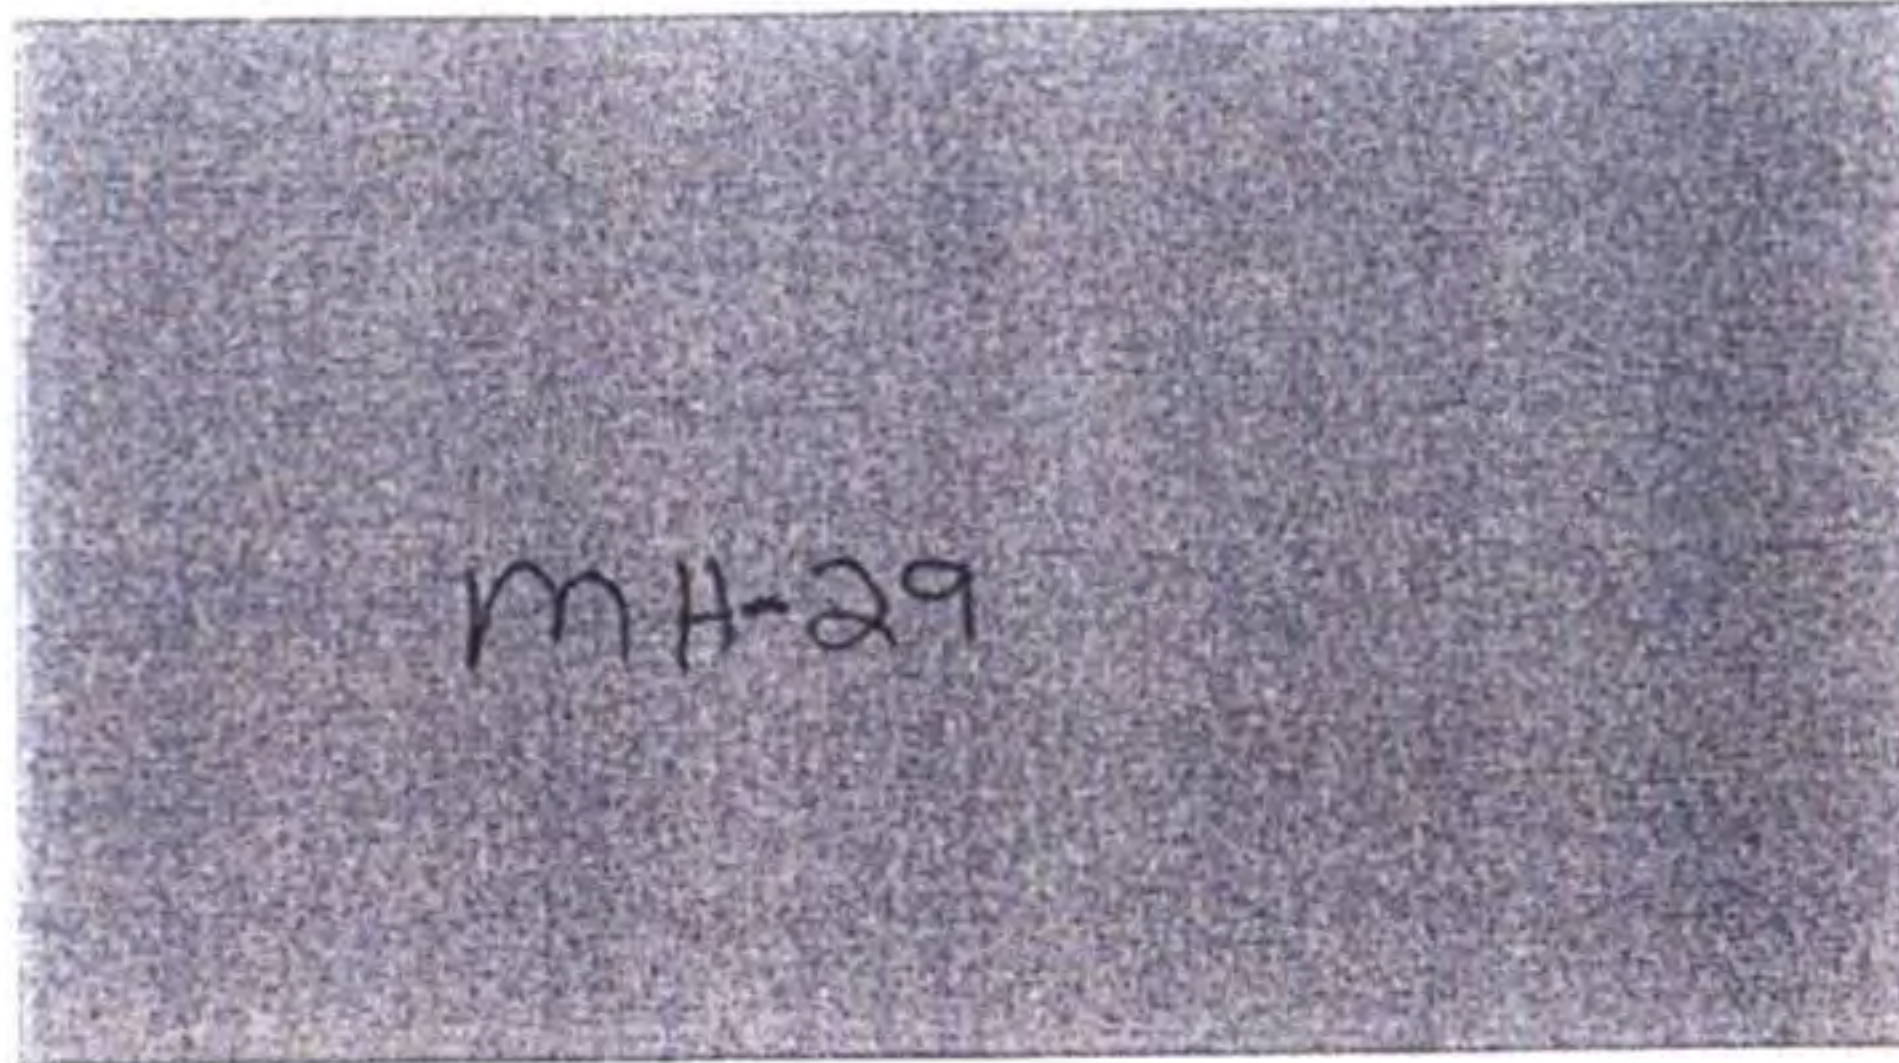
## Calculating Rectangular Spill Areas

Date: 10/26/06 Location: 923 Biddle St. Employee #: 5236

Length of Spill (Ft): 10' (1)

| Convert Cubic Feet to Gallons: | <u>18,700</u> | (6) = (5) x 7.48 |
| Report Estimate Discharge Volume: | <u>18,700 Gallons</u> | (6) |
