# Annual MOM Progress Report

2005

Submitted to EPA on February 27, 2006

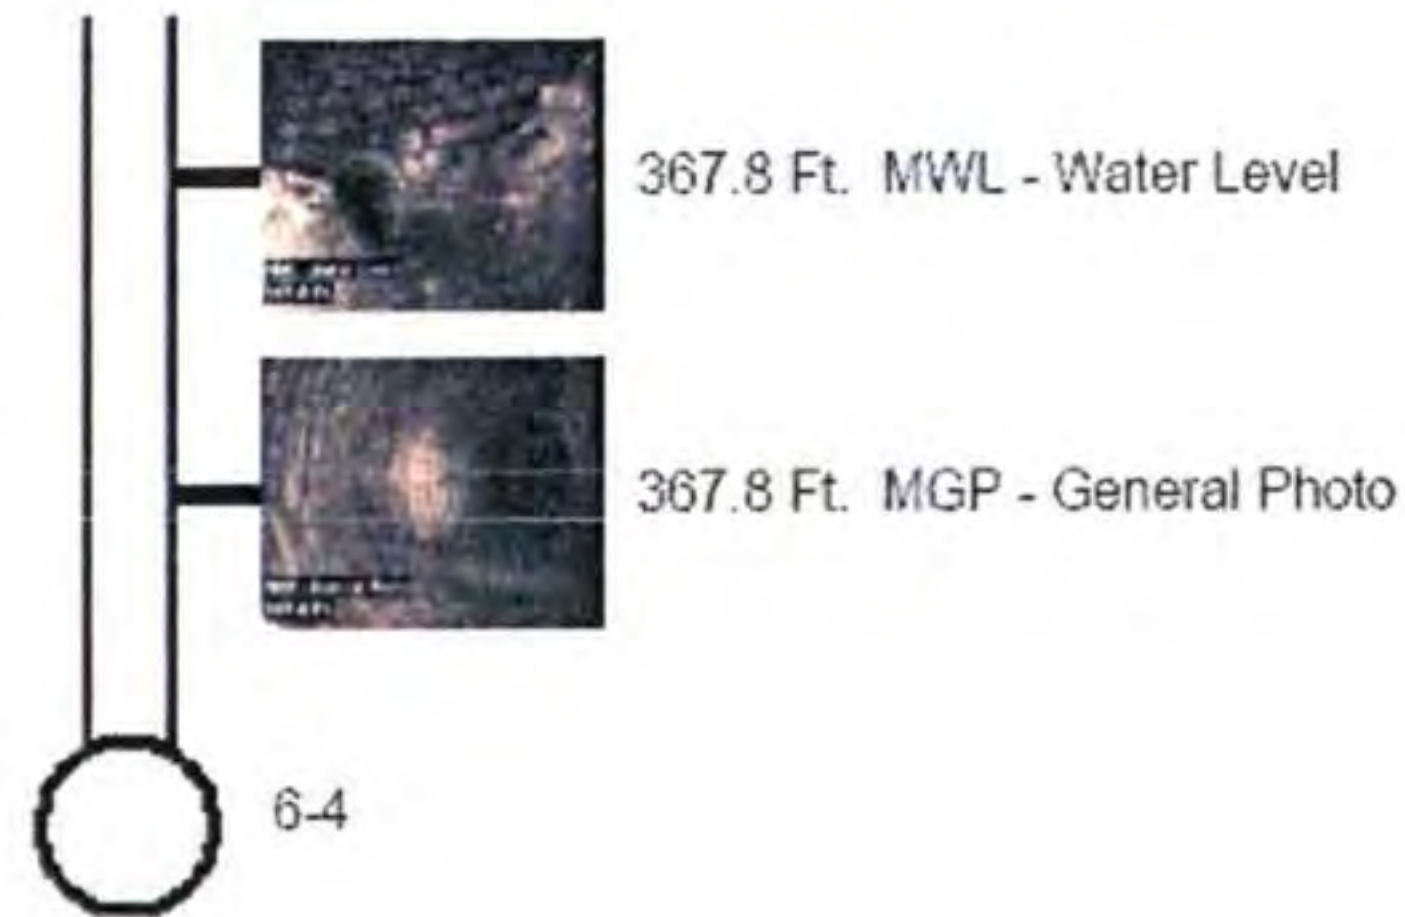
| Drain Area<br>Third Creek | Sub Basin<br>22 | N/A | | Up MH<br>6-4 | Down MH<br>6-3 | | |
| Pipe Seg Ref<br>1153717 | Mtl<br>Concrete Pipe (non-reinforced) | Shape<br>Circular | Height<br>8 | Width<br>8 | Jt. Lgth.<br>4 | Total Lgth.<br>368 | Lgth. Surv.<br>367.8 |

Pipe IPID: 1153717 Manhole 1: 6-4 Address: 1206 PROCTOR ST Work Order ID: 26982789  
 Subbasin: 22 Manhole 2: 6-3 Address: 1323 PROCTOR ST  
 CAPCredit: \*  
 Follow Up: \*  
 Comments: flushed and tved main for mike hillard  
 System Disruption: \*
