2001-2008 Sanitary Sewer Overflow Evaluation Report

Including Building Backups and Trend Analysis

Submitted to EPA on April 28, 2009

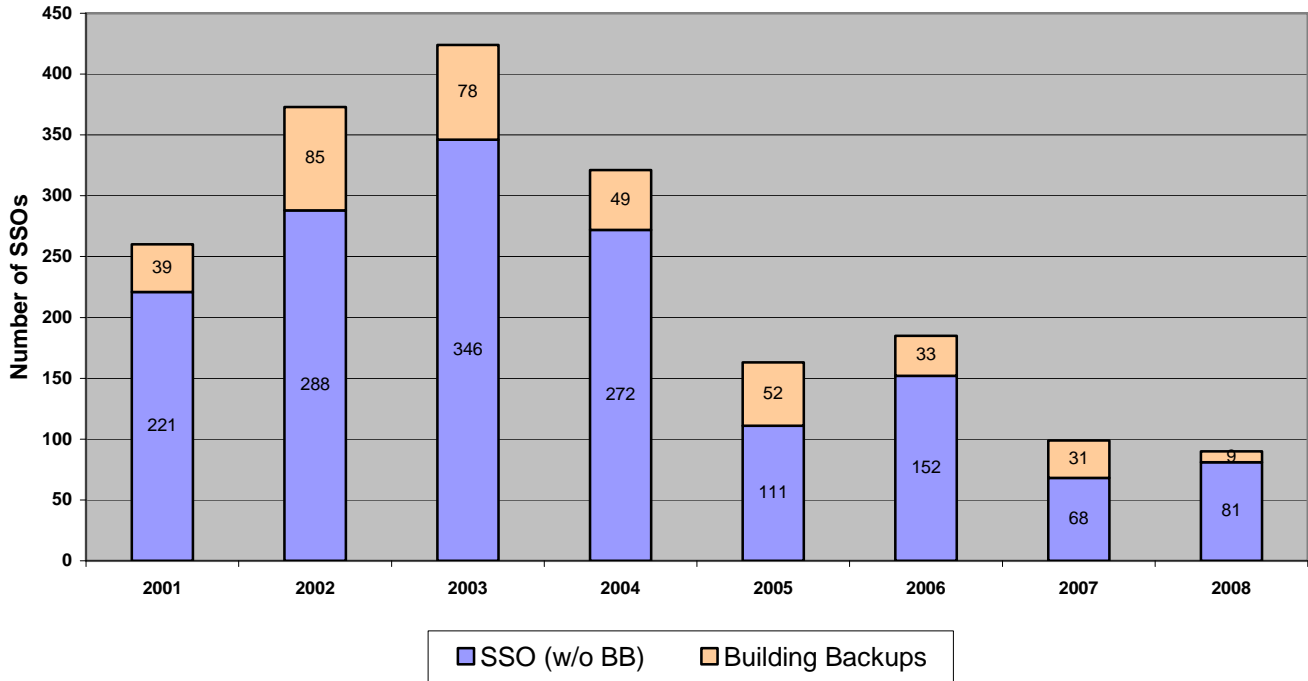
Figure 1 illustrates the annual number of overflows and building backups. The number of overflows and building backups increased from 2001 to 2003. As illustrated in this graph, both categories decreased in 2004, when KUB began PACE 10 efforts. The number of overflows in 2005 decreased by 59 percent while the number of building backups increased slightly from the 2004 total. In 2006, the number of building backups decreased by 36 percent. KUB successfully worked with cleaning crews to decrease the number of backups related to flushing operations. SSOs increased by 27 percent in 2006. This increase can be attributed to a three-day period of rain in September. During this event, rain gauges across our service territory recorded between 4.39 and 5.88 inches of rain with 1-day (24 hour) totals between 3.95 and 5.05 inches. This event, which exceeded a 25-year 24-hour storm return period, resulted in 33 rainfall-related SSOs. Those 33 events accounted for 49 percent of the wet weather SSOS that occurred during 2006.

**Annual Sanitary Sewer Overflow Totals
(including Building Backups)**

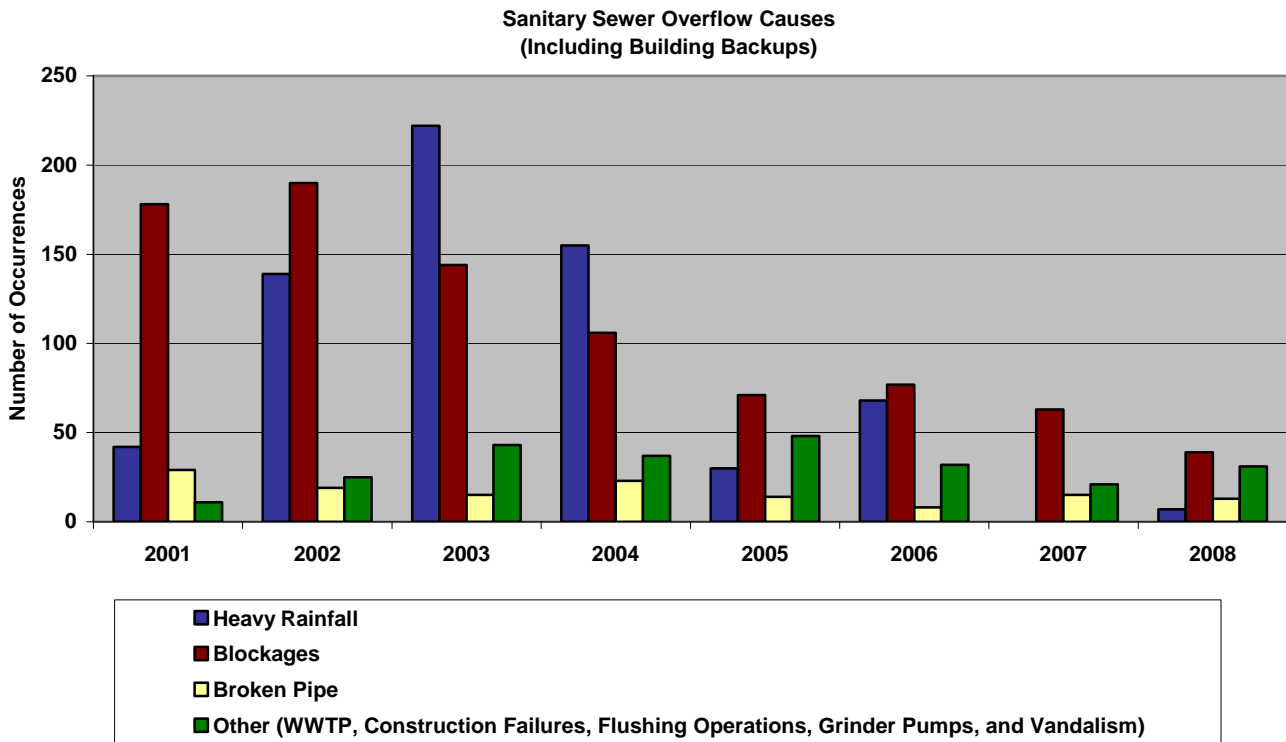
Figure 2 presents a comparison of SSOs by causes. In this graph, the SSOs were grouped into four categories:

- Heavy Rainfall
- Blockages (Debris, Grease, and/or Roots)
- Broken Pipe
- Other (Construction Failures, Flushing Operations, Grinder Pumps, Vandalism, WWTP, and Pump Stations).

The SSOs for 2001 through 2008 are grouped into one of four general categories by each year. As illustrated in Figure 2, blockage-related events were the major cause of SSOs in 2001, 2002, 2005, 2006, 2007, and 2008. Rain was the largest contributor in 2003 and 2004. The number of rainfall-related events increased in 2006 due to one significant 3-day rain event in September. Increased cleaning, root removal, Grease Control Program improvements, and replacement/rehabilitation of problem lines continue to decrease the number of events, duration, and volume. With 2003 having the highest number of events due to heavy rainfall during the period reported, the 97 percent decrease since then can be attributed to the success of line replacement and rehabilitation projects. In 2006, the Walker Springs and Lower First Creek storage tanks became operational. Two additional tanks went online in 2007; Upper First Creek and Third Creek. The use of these four storage tanks during heavy rainfall events reduces the number of overflow events at chronic sites and elsewhere in the system downstream.

The Heavy Rainfall category includes SSOs that were a direct result of rain events. This category represents events that were generally caused by heavy rainfall in the area that resulted in high flows in the collection system.

The Blockages category represents SSOs that were caused by debris, grease, roots, or some combination of the three.

The Broken Pipe category includes SSOs that were a direct result of a broken or damaged pipe.

The Other category includes SSOs that were caused by construction failures, flushing operations, grinder pumps, vandalism, or WWTP or pump station failure (mechanical, electrical, or electronic).

Broken pipe-related overflows decreased by 13 percent from 2007 to 2008. The return to normal rainfall levels helps to moisten the ground and prevent shifting.

The 32 percent increase in events in the Other category is mainly due to increased inspections of KUB-owned grinder pumps. Inspectors frequently discovered and reported SSOs due to electrical failure. In response, KUB has implemented a preventive maintenance program for grinder pumps. The increase can also be attributed to increased dig-ins by contractors, construction failures due to contractors failing to reconnect service laterals, and failures of pump-around efforts. One pump-around failure occurred due to vandalism and copper theft. KUB continues to work with contractors to reduce SSOs and building backups due to construction failures.

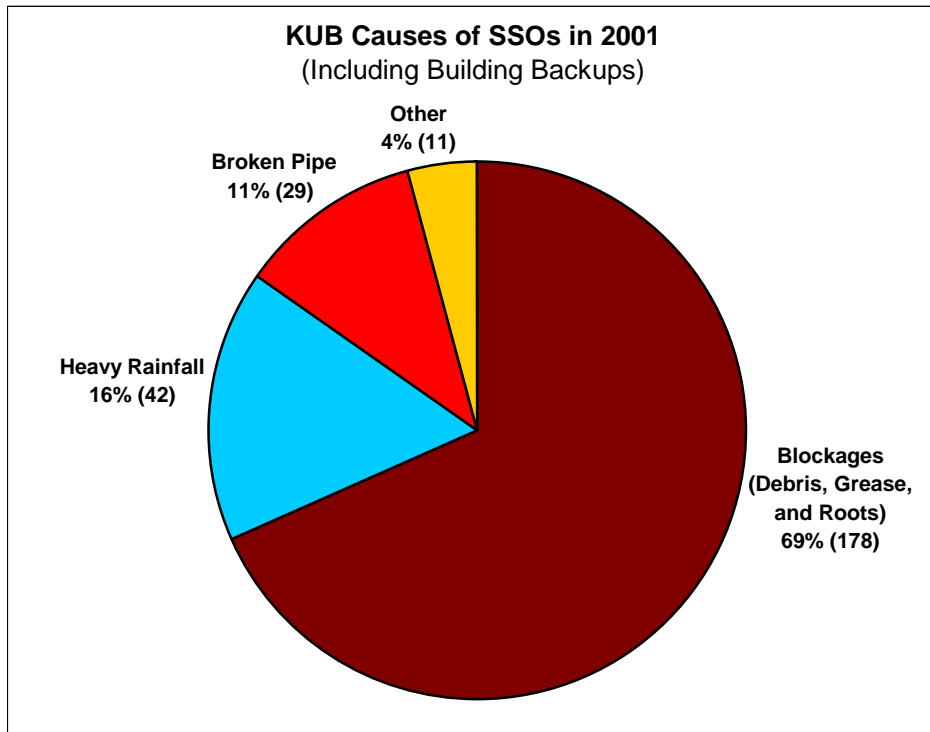
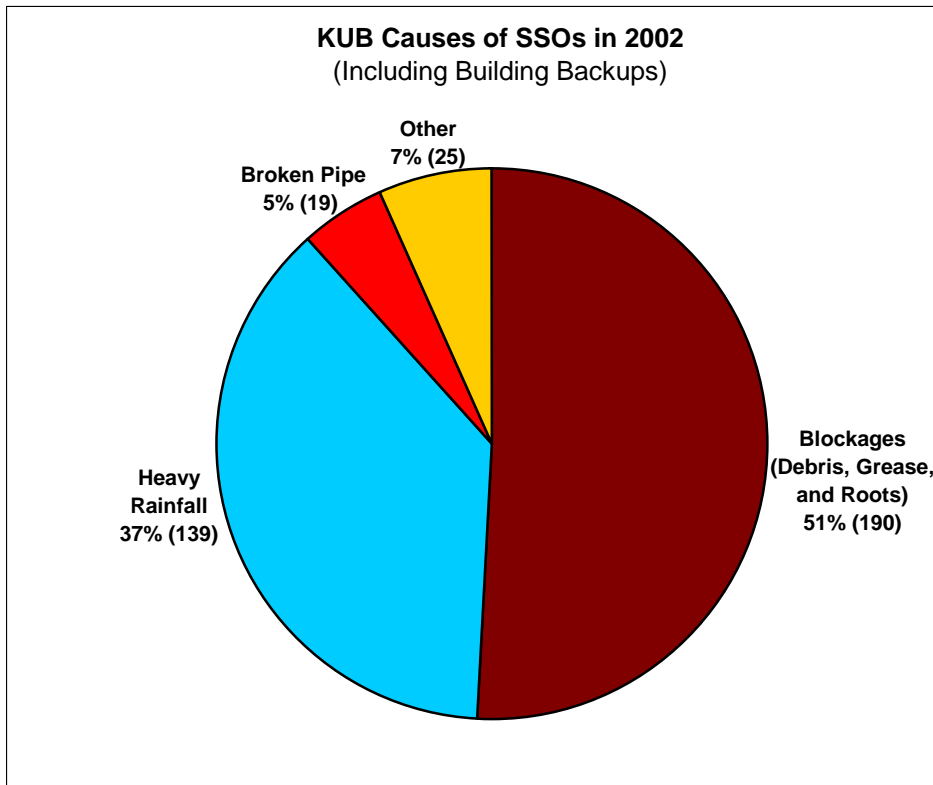
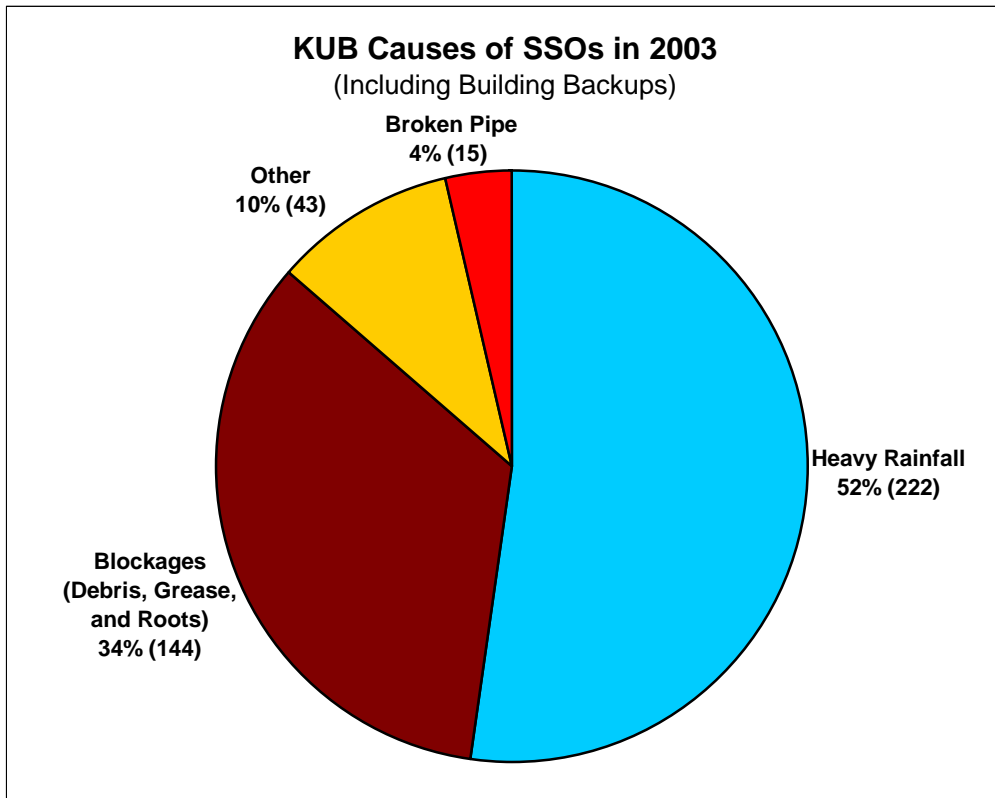
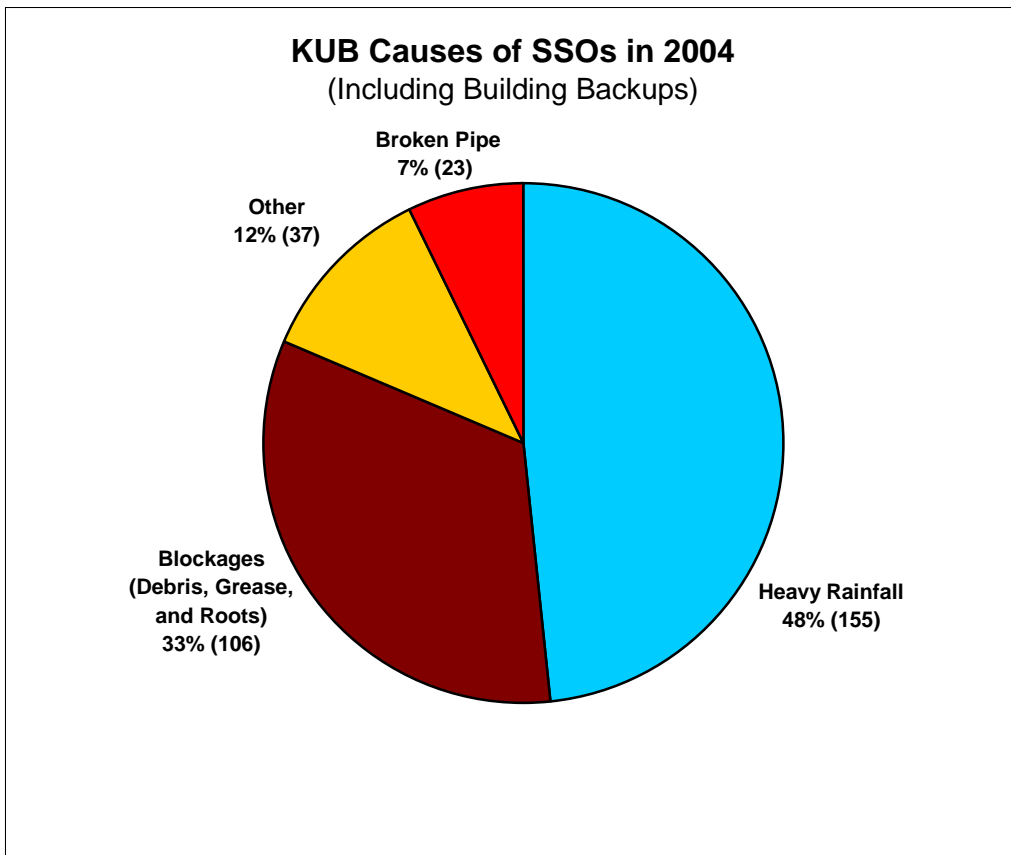
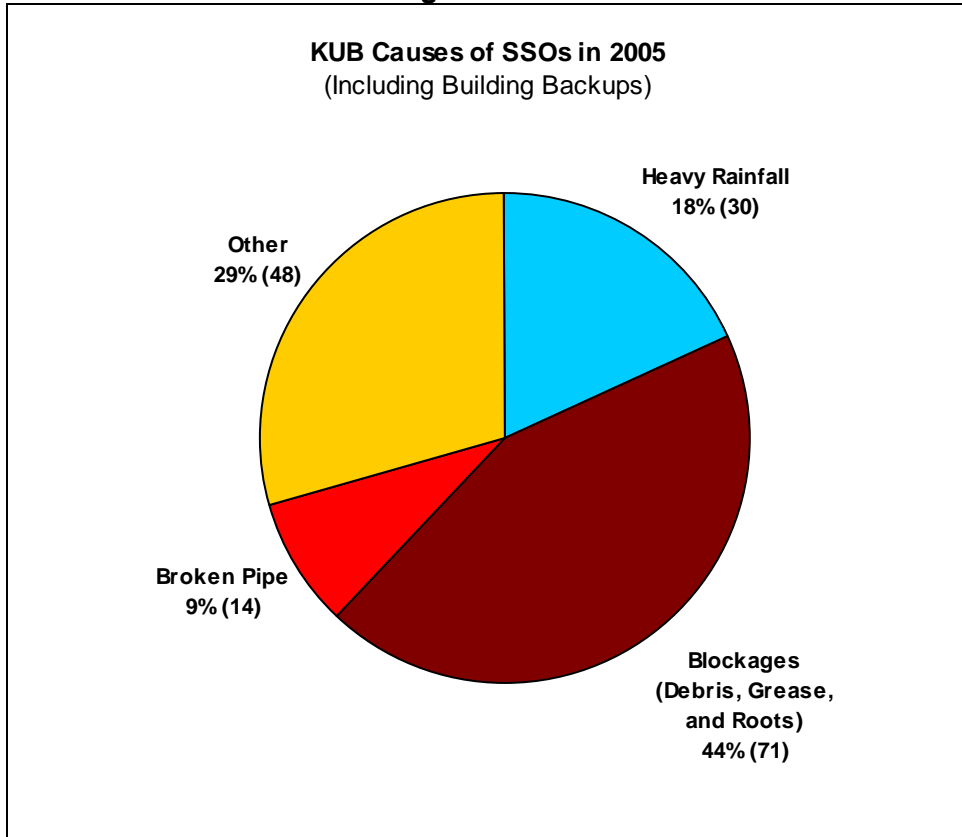
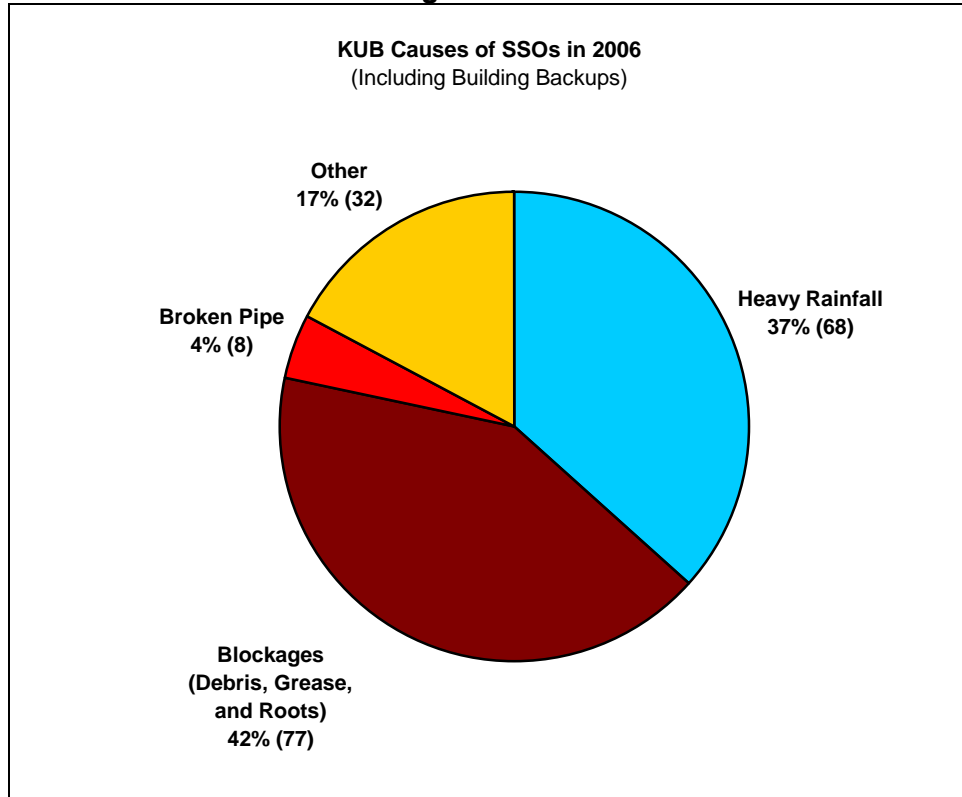
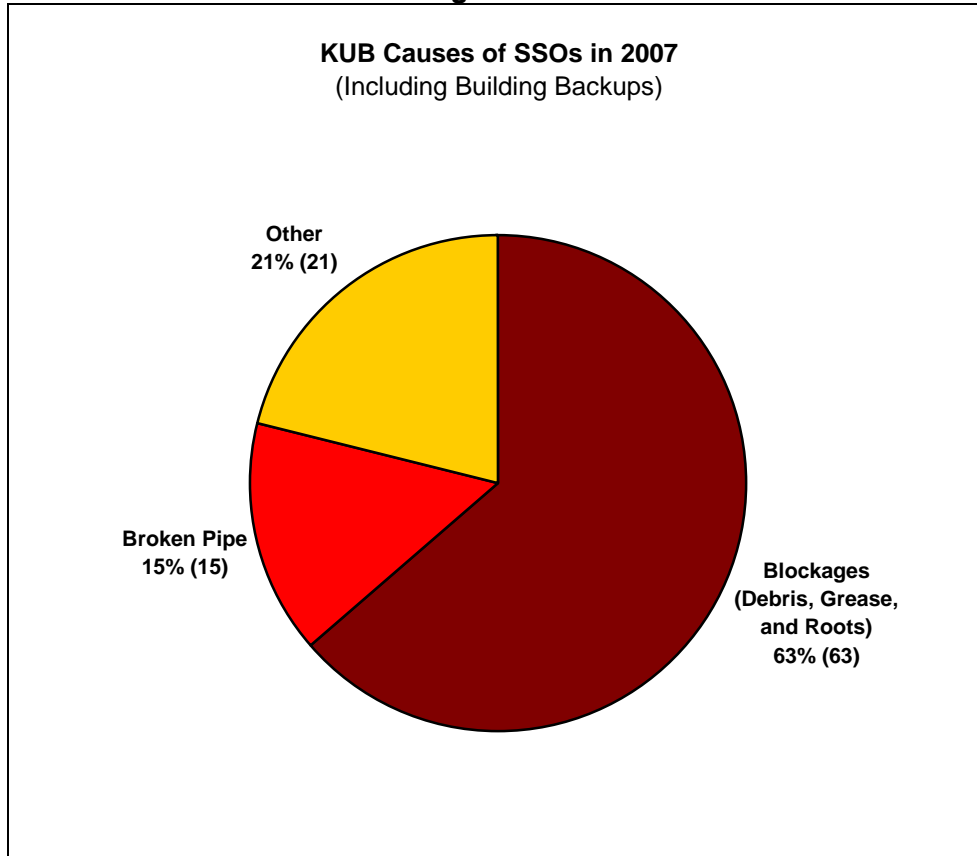
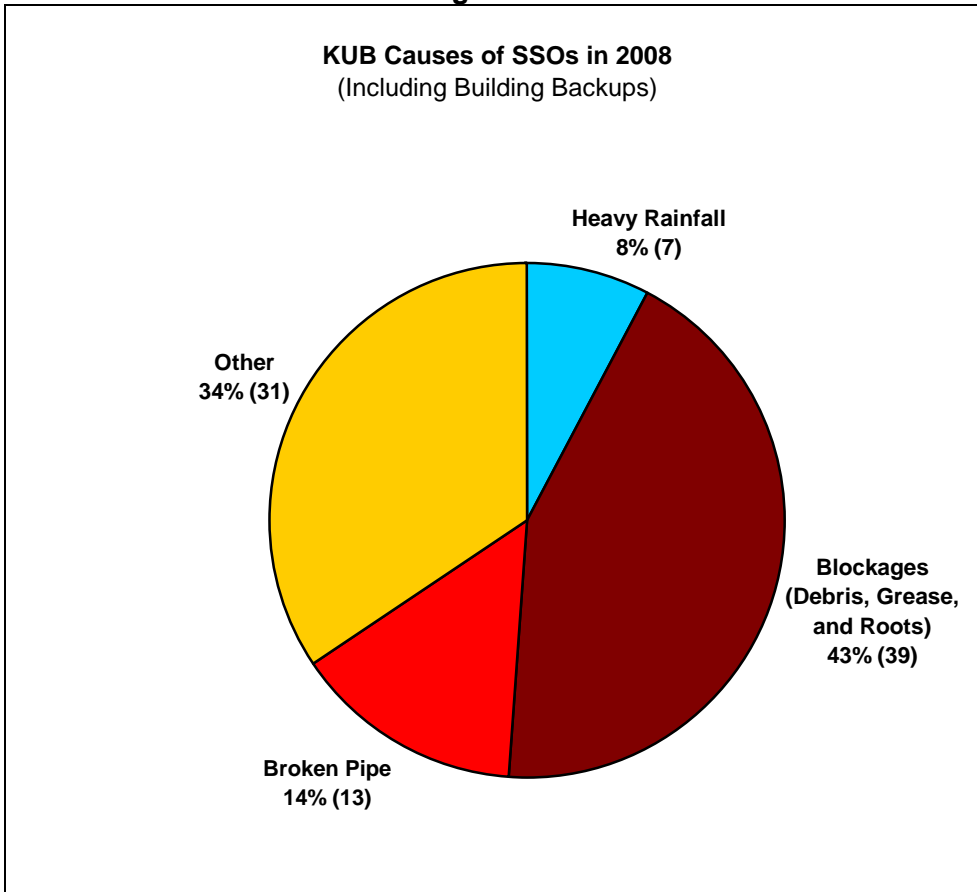
Figures 3.A-H illustrate the specific causes of SSOs that occurred from 2001 to 2008.

- Wastewater Treatment Plant (WWTP) and Pump Station Failures
These events resulted from a failure at a WWTP or pump station, such as a mechanical or electrical failure.

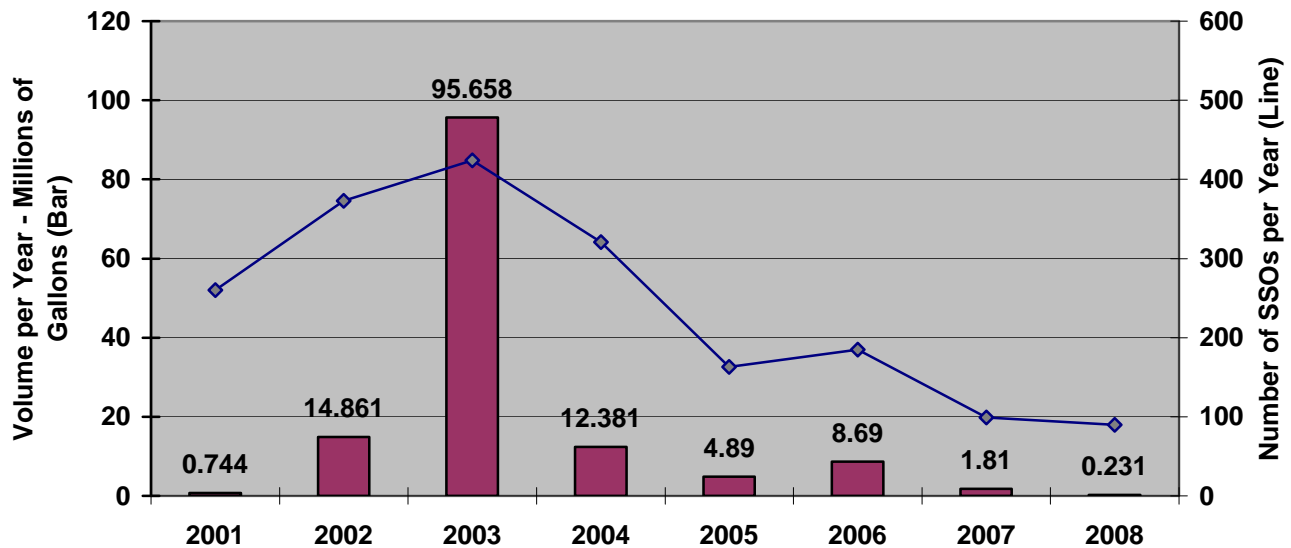
Figure 4.A

Figures 4.A and 4.B represent the SSO volumes between 2001 and 2008. For Figure 4.B, the SSO volumes were grouped into four volume ranges:

**Total SSO Volume per Year
(Including Building Backups)**

The dramatic decrease in total volume from 2006 to 2007 more attributed to very low rainfall. All of the overflows that occurred in 2007 were dry weather events. It is important to note that KUB strives to recover as much volume as possible during each event. Volume continued to decrease (99 percent) in 2008. Only one event during 2008 resulted in a greater than 100,000 gallon loss. Events are identified earlier which has resulted in smaller discharges. Also, the utilization of KUB's four new storage facilities

and rehabilitation efforts has significantly reduced the flows in the sewer system during heavy rainfall events. With a return to normal rainfall levels in 2008, chronic overflow locations have nearly been eliminated.

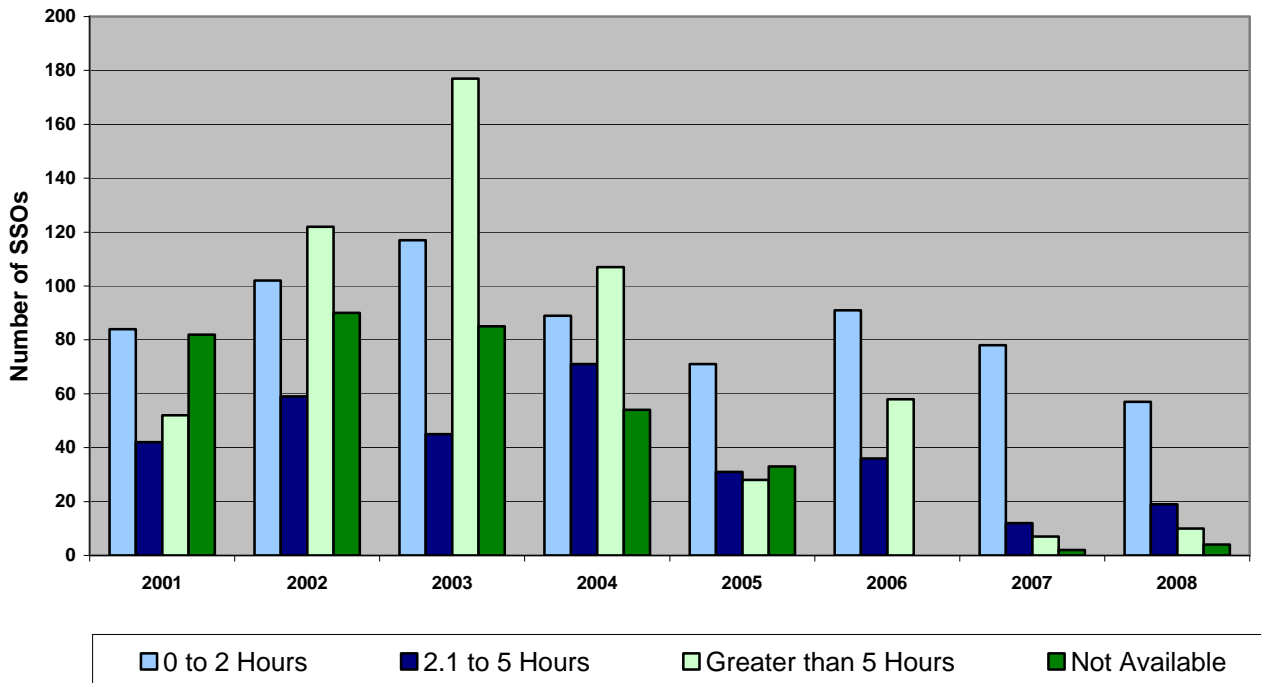
Figure 5

Sanitary Sewer Overflow Durations (Including Building Backups)

0 to 2 hours

This category shows a steady increase until 2003 and then a decline in 2004 and 2005, followed by a slight increase in 2006. Durations again decreased in 2007 and 2008. With this category having the highest number of events from 2005 to 2008, the increased
