2003-2011 Sanitary Sewer Overflow Evaluation Report

Including Building Backups and Trend Analysis

Submitted to EPA on April 27, 2012

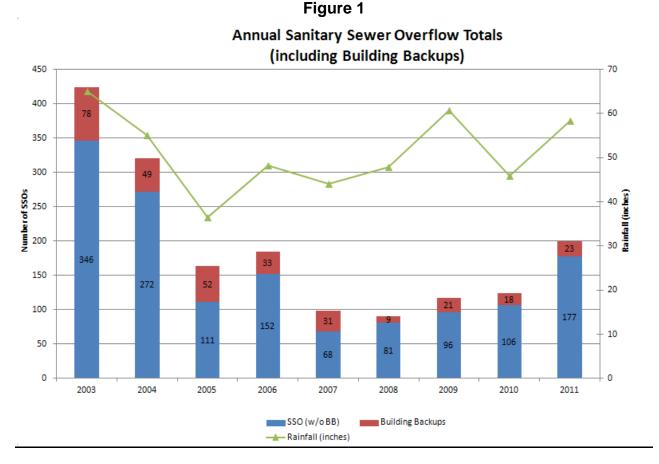
Annual Sanitary Sewer Overflow Totals

Figure 1 illustrates the overall significant decline in sanitary sewer overflows, including building backups over the last nine years. The slight increase in 2006 relative to the previous year can be attributed to a three-day period of rain in September. During this event, rain gauges across our service territory recorded between 4.39 and 5.88 inches of rain. This event, which exceeded a two-year 24-hour storm return period, resulted in 33 rainfall-related SSOs. Those 33 events accounted for 49 percent of the wet-weather SSOs that occurred during 2006.

The total number of SSOs continued to decrease again after 2006 until 2009 when the annual rainfall and weather conditions began to affect the decline. The Knoxville area experienced a 27 percent increase in rainfall during 2009 compared to 2008. There were 47.75 inches of rainfall in 2008 and 60.66 inches in 2009, as reported by the National Weather Service (NWS). This amount

of annual rainfall had not occurred since 2003 when the area received 65 inches of rain throughout the year, but in 2009 only 29 wet-weather SSOs occurred compared to over 200 in 2003. Then in January of 2010 our service area received an additional six inches of rain when the ground was already saturated from six inches of rain in December. These soil moisture conditions from 12 inches of rain in the prior 60 day period helped produce 16 SSOs at the very start of 2010 or 50 percent of the wet-weather SSOs reported for that year.

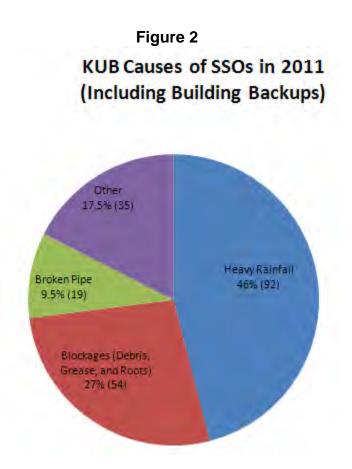
Causes of Sanitary Sewer Overflows

Figure 2 presents a comparison of SSOs for 2011 by causes. In this graph, the SSOs were grouped into four categories:

- Heavy Rainfall
- Blockages (Debris, Grease, and/or Roots)
- Broken Pipe
- Other (Construction Failures, Grinder Pump Failures, and Pump Stations).

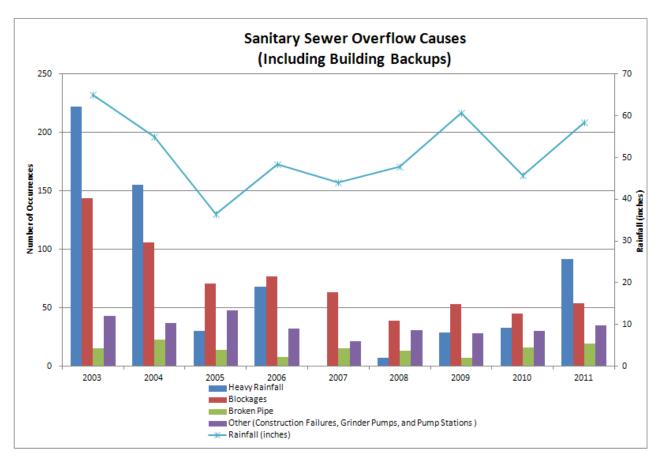
The SSOs are also grouped into one of four general categories by each year in Figure 3 for analysis. System cleaning, root removal, tank construction, and replacement/rehabilitation projects continue to decrease the number of events, duration, and volume.

As illustrated in Figure 3, blockage-related events have been the major cause of SSOs in recent years, but they have declined by almost 63 percent since 2003. Blockage-related events increased from 45 in 2010 to 54 in 2011, which can be explained by the amount of rainfall received, especially with increased collection system flows following an extended dry period. This is seen in the slight increases in 2006, 2009, and 2011 relative to the previous years. There were at least 10 blockage-related events in 2009 that occurred in conjunction with higher flows, seven in 2010, and 11 in 2011. Grease and debris tend to accumulate in the collection system during dry periods with lower than typical flows. Higher flows following rainfall events can then move these materials through the system and cause blockage-related overflows at another location.

Figure 3 indicates rain was the largest contributor to SSOs in 2003 and 2004, but the impacts of rain have decreased over time due to system rehabilitation and storage tank construction. Following the 2007 drought year, during which no events were caused by heavy rainfall, normal rainfall in 2008 caused seven events. Since 2008 there has been an increase in wet-weather overflows that can also be attributed to the influence of rainfall. The heavy rainfall (61 inches) in 2009 caused an increase in wet-weather events relative to the prior two years. This amount of annual rainfall had not occurred since 2003 when the area received 65 inches of rain throughout the year. Rainfall exceeding three inches in 24 hours in January 2009 produced 15 wet-weather related events, notably less than the 33 overflows observed under similar conditions in 2006. Another similar rainfall in September produced seven events. These intense rainfall conditions exceeded a two-year 24-hour storm return period and produced a total of 22 overflows.

Figure 3 shows SSOs due to broken pipe fluctuate slightly but overall the trend has been fairly constant (less than 20 SSOs) over the last several years. There were 19 SSOs due to broken pipe in 2011. Ground conditions can cause pipes to shift weakening joints. KUB continues to proceed with a significant amount of system rehabilitation and main line replacement to keep occurrences related to broken pipes low. Over 190 miles of pipe have been rehabilitated since the beginning of the PACE 10 program.

As Figure 3 indicates 'Other' causes decreased after 2005 on average about 50 percent, but remained somewhat flat in recent years. KUB continues to look closely at the specific causes within this category to eliminate SSOs, whenever possible. This year 18 SSOs and building backups were caused by grinder pump failures, representing over 51 percent of total SSOs in this category. In 2011, all 135 KUB owned grinder pumps were assessed. During this assessment, each pump was repaired according to the results of the inspection to bring all grinder pumps up to a base level for evaluation. Based on these results, each grinder pump was prioritized and set on a more aggressive maintenance schedule to help prevent future SSOs.

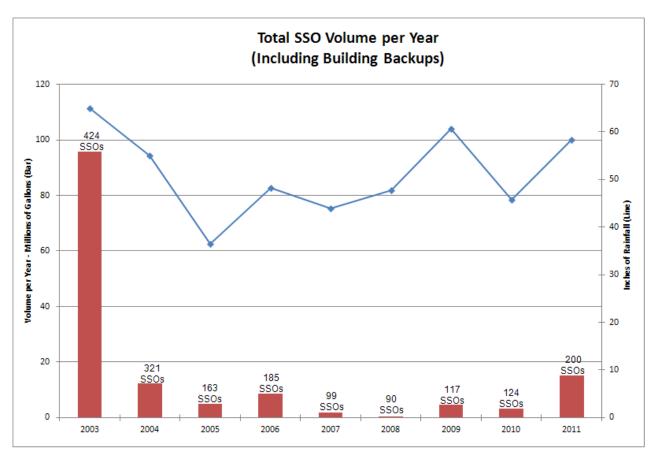
Sanitary Sewer Overflow Volumes

Figures 4.A and 4.B represent the SSO volumes between 2003 and 2011. For Figure 4.B, the SSO volumes were grouped into four volume ranges:

Total volumes have decreased by over 84 percent, from 95.66 million gallons in 2003 to 15.15 million gallons in 2011. The dramatic decrease in total overflow volumes from 2006 to 2007 is attributed to very low rainfall totals. All of the overflows that occurred in 2007 were dry-weather events. This downward trend continued in 2008 with the use of four storage tanks to help manage peak wet-weather flows. The increase in 2009, 2010, and 2011 was a result of increased rainfall, and particularly the result of individual rainfall events of significant magnitude.

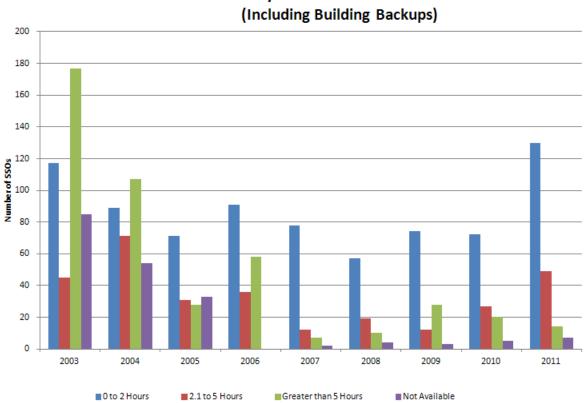
Figure 5 Sanitary Sewer Overflow Durations (Including Building Backups)

Figure 5 represents the SSO durations between 2003 and 2011. Durations are typically based on the amount of time elapsed since the overflow was first observed until the time the overflow was observed to have stopped. In cases where KUB can document or has reason to believe the overflow had been ongoing prior to observation, durations may be estimated. In many cases, KUB mitigated the overflow shortly after confirmation of the event. The SSO durations were grouped into four ranges:
